Albarakah Investment Holding Company L.L.C.

Installation Date: March 26, 2016

Steam Boiler Room of 1 Bldg of Workers Village

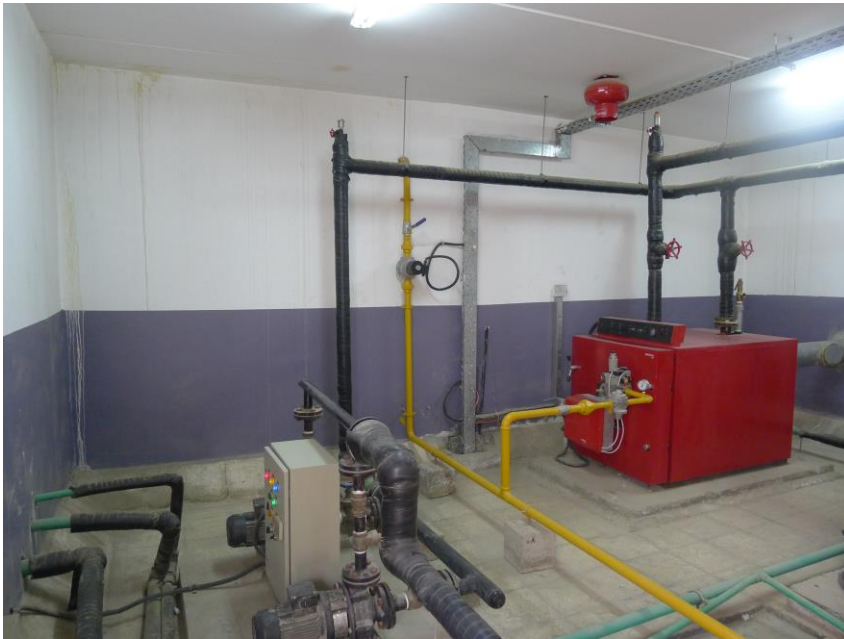
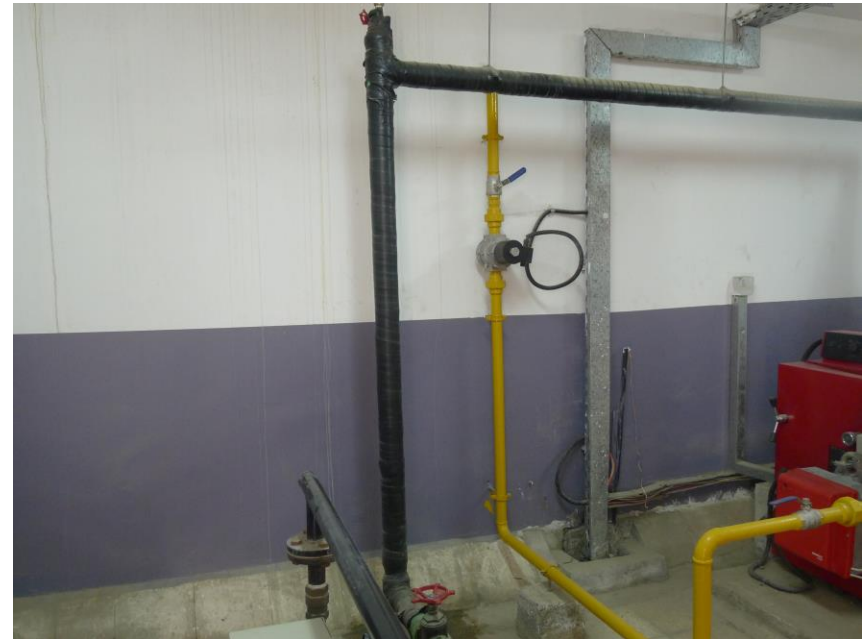
Pipeline system of the building

Identified pipeline of the boiler unit

Invested Units Affected by Corrosion

Replaced piping materials due red rust.

Corroded inside area of the pipe system with some scaling. A strong that water is in acidic conditions.

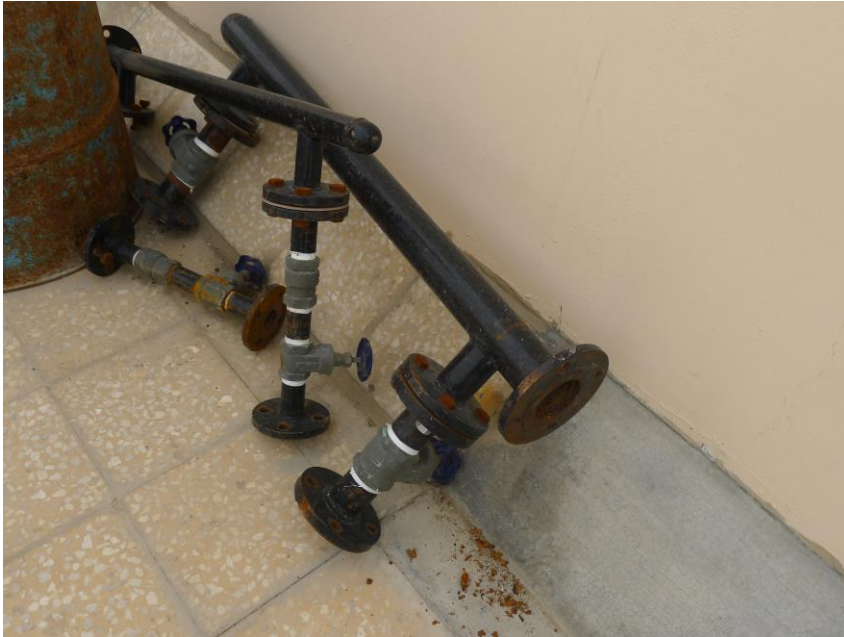
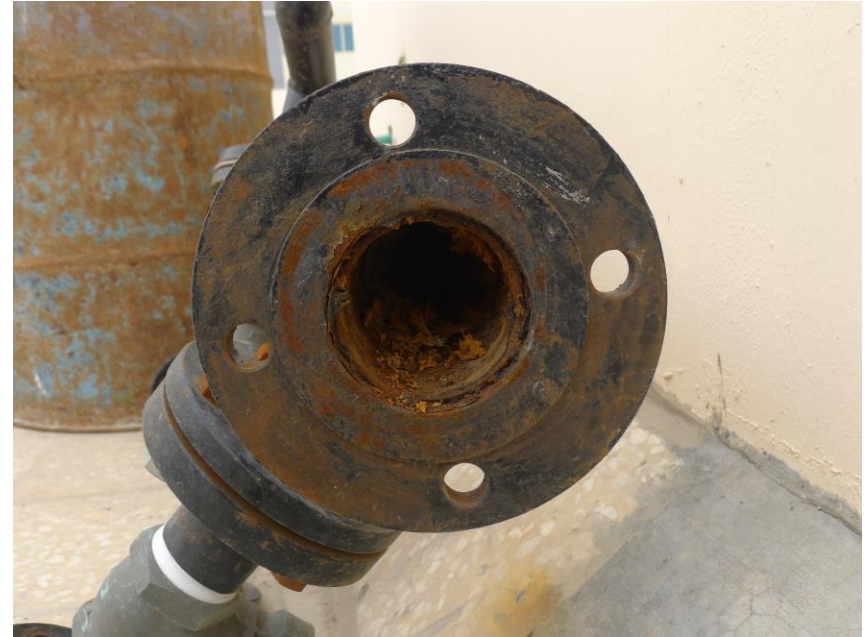
SW 5 Star Model Installed for the Boiler Unit

Identified 2" pipe for 5 Star Model of SW.

Actual coil done with single layer-38 loops of the coil.

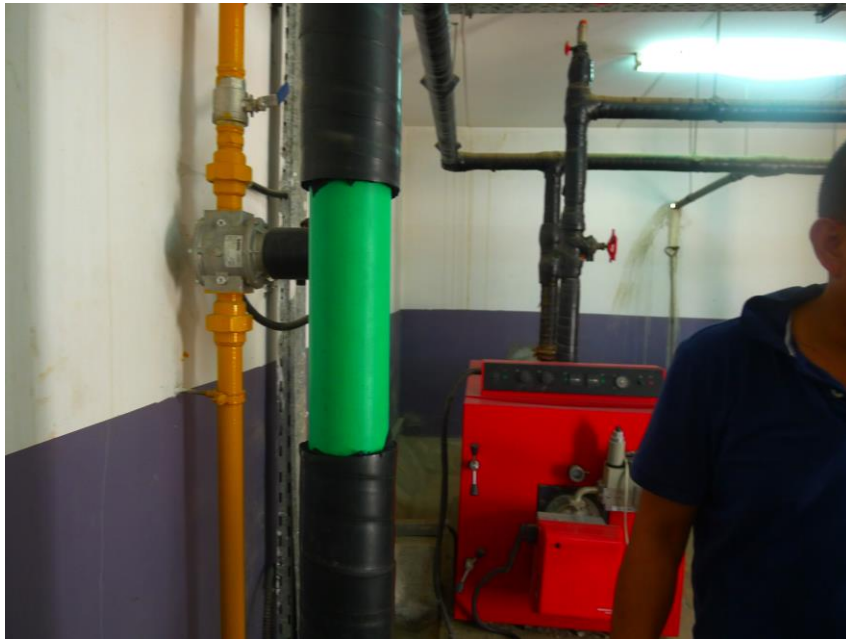
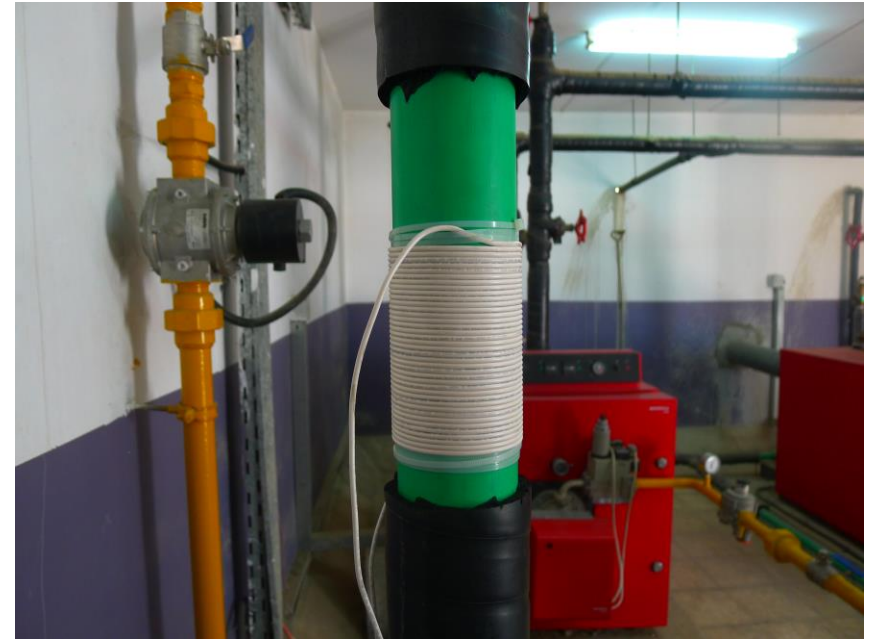
IE 4 SW Model Installed for the Storage/Holding Tank of the Steam Boiler Unit

Coil installation for IE-4 SW Model

1st layer of the coil with 60 loops

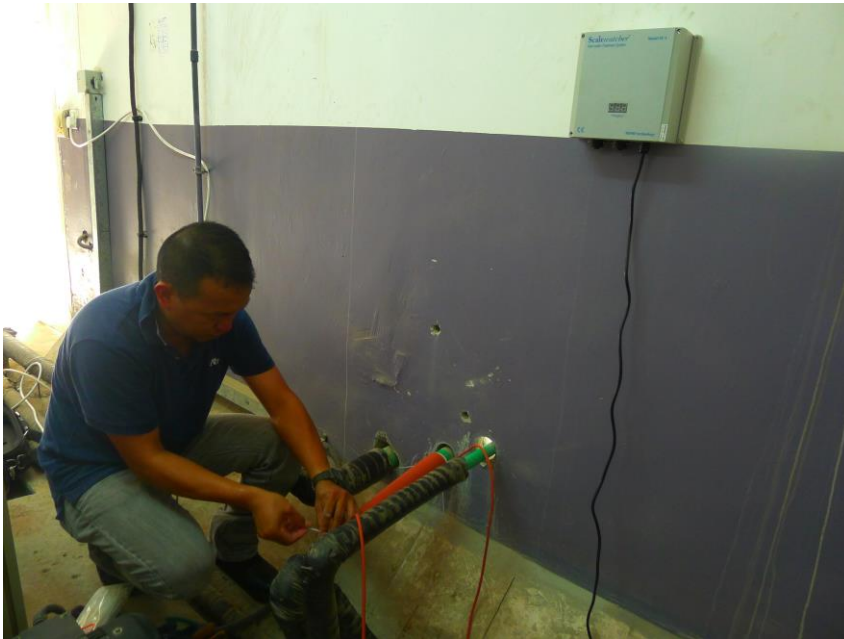
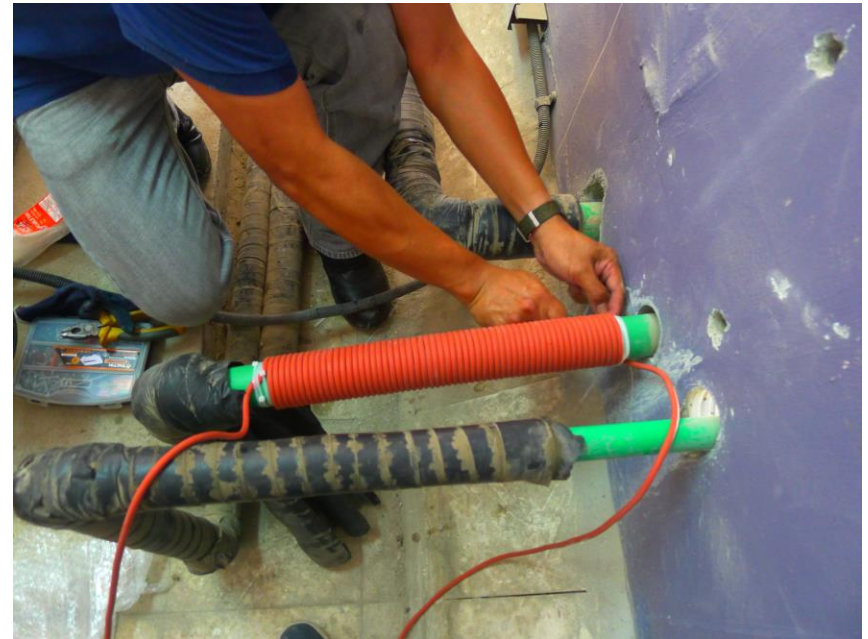
IE 4 SW Model Installed for the Storage Tank of the Steam Boiler Unit

2nd layer of the 60 layer loop

Sealing of the finished 2 layer by 60 loops of coil for IE-4 SW unit

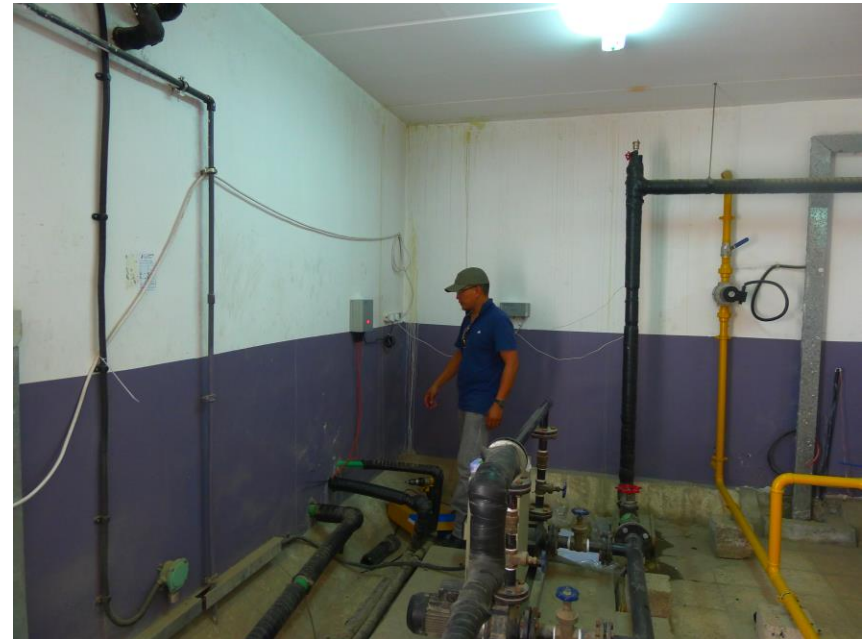
Finished Installation of 5 Star and IE-4 SW Models

Observation(s) after installation:

- The invested units such as the pumps, pipeline and other high value equipment are greatly affected by scaling and corrosion caused by water hardness.
- Shutdown operation and high usage of descaling chemicals is the existing maintenance program which is very expensive for the company.
- Water parameter in the area are as follows:

Boiler unit- pH is 5.0-5.5 and water hardness is 140ppm

Storage/Holding Tank- pH is 6.0 and water hardness is 120ppm

-the low or acidic pH of the water in the boiler system is the main reason of high corrosion of boiler system and pipelines which is a high operational expenses for the company.
