Final Monitoring Report

Fraser Suites- Seef District
Kingdom of Bahrain

ScaleWatcher(SW) Water Treatment Report for the 20-Storey
Building Main Water Line and RO System

September 11, 2016

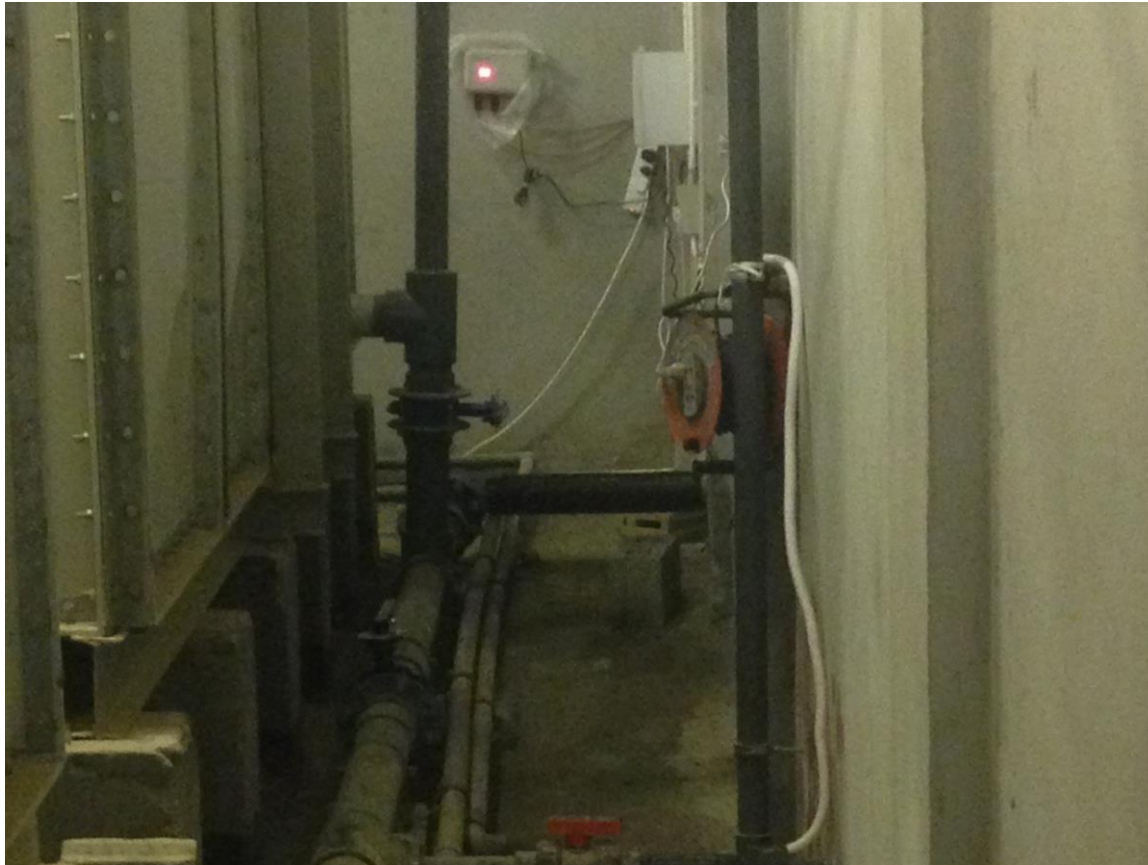
Fraser Suites Seef District- 20 Storey Building Main Water Supply Treatment with SW Electronic Water Treatment

IE8 SW Model installed in the 4” outlet pipe of the water storage tank with 1 set of coil of 85 loops.

IE4 SW Model installed in the 2.5" inlet pipe of the water storage tank with 2 sets of coil of 55 and 42 loops.

CM2 SW Model installed in the 1.5" main inlet pipe of the RO system with double layered coil of 32 loops.

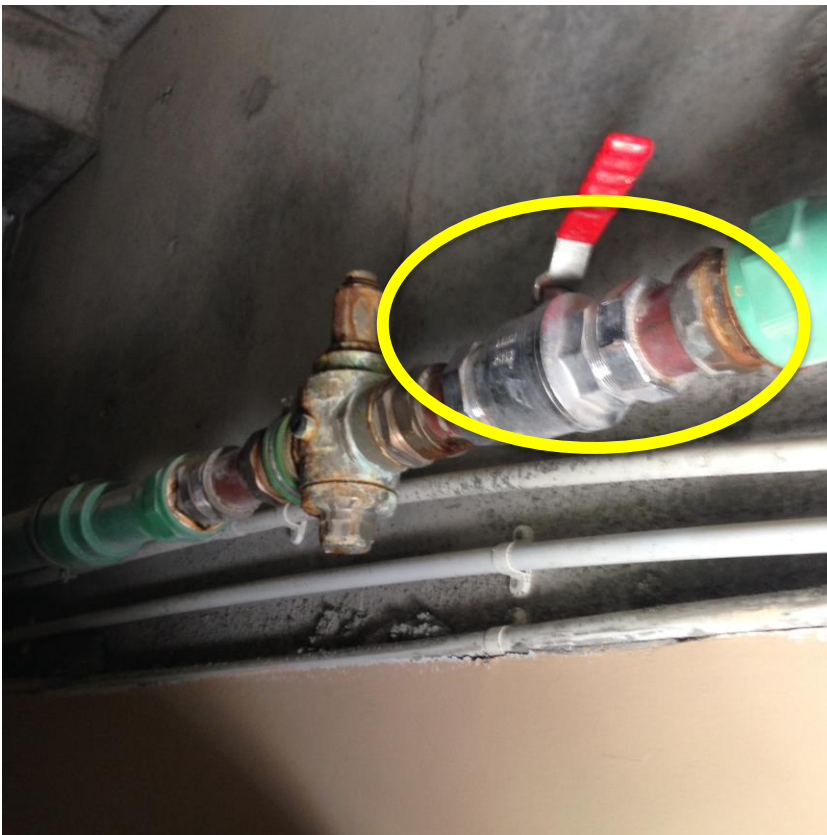
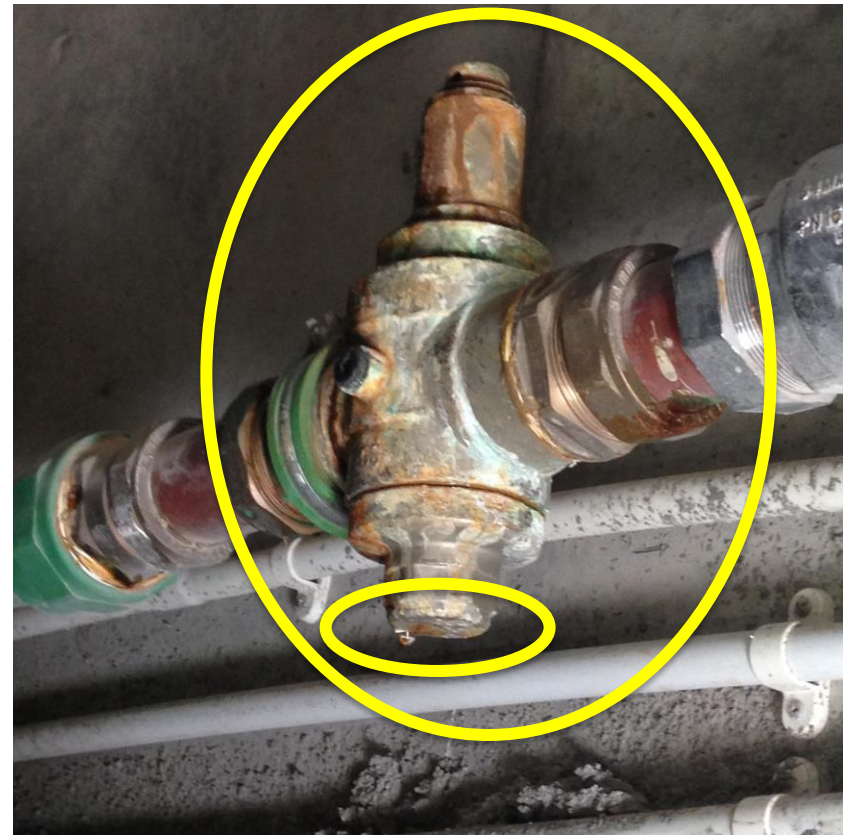
Water heaters affected by scaling and corrosion

- *Hard external scaling and hard red rust in the pipe fittings and pump and water heater area were present and affecting the said water applications.

Hard scales and corrosion before SW installation.

- Monitor the status of the water heaters and compare the frequency of replacing the heating elements and compare to the records of expenses before the SW s installed.

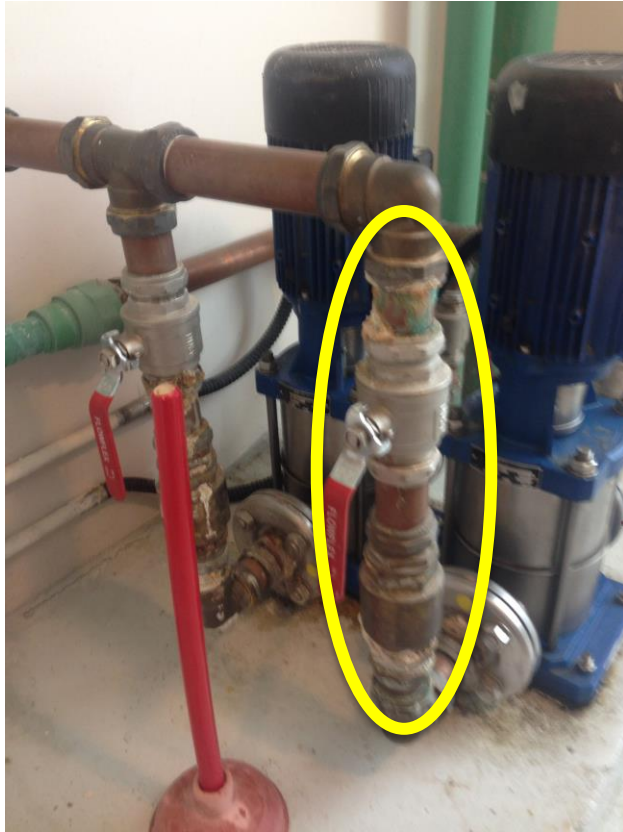
Other unit affected by the same problems.

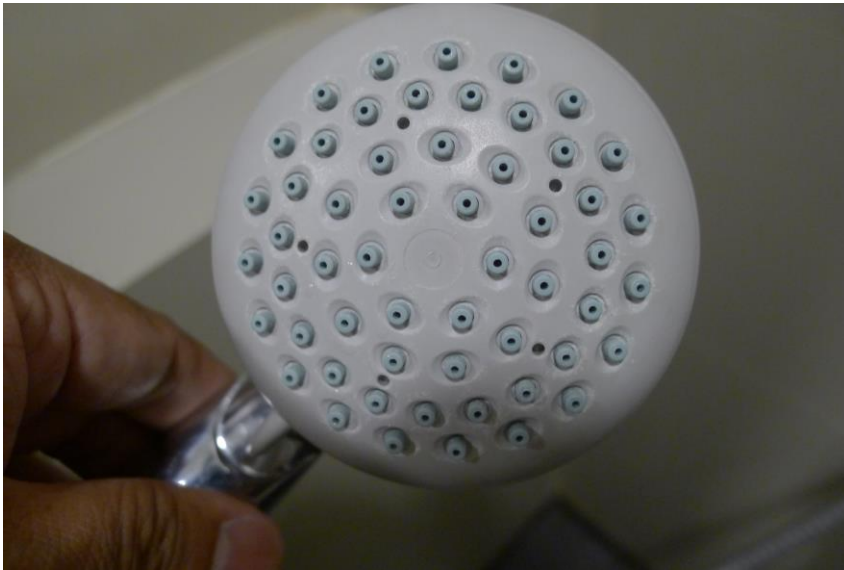
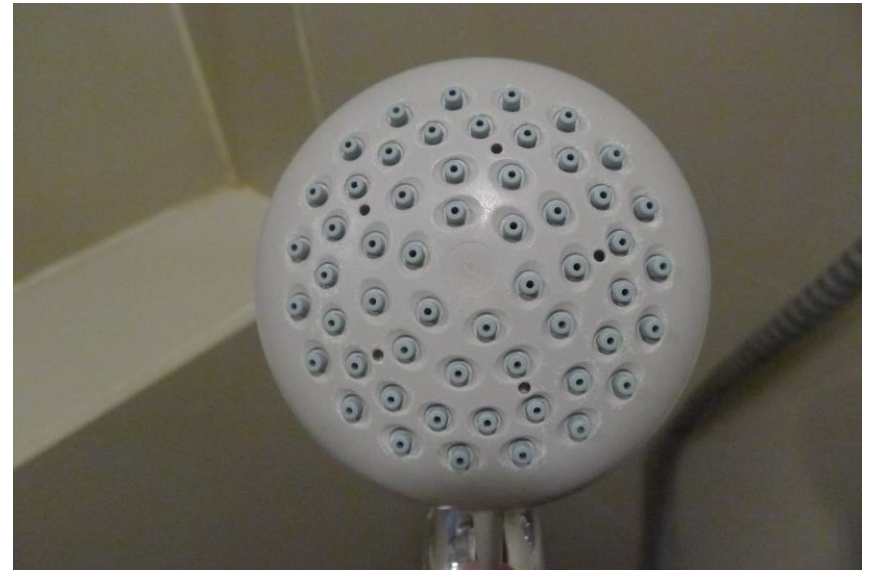
Indoor Fountain Status After SW Installation

August 10, 2016- Initial status wherein there are some hard scales that has developed through time, the metal sprinkler looks to be dull in appearance.

August 28, 2016- after 18 days of SW treatment without any chemical wherein the scales has started to soften, the stainless surface appears to be more shiny and clean.(noted by Mr. Michael Datan)

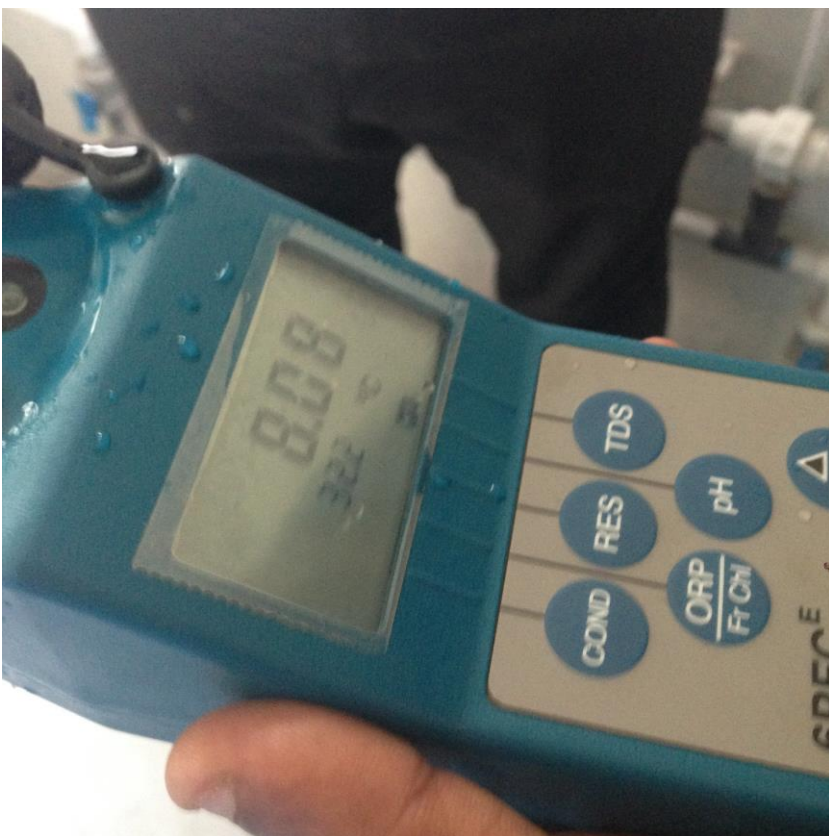
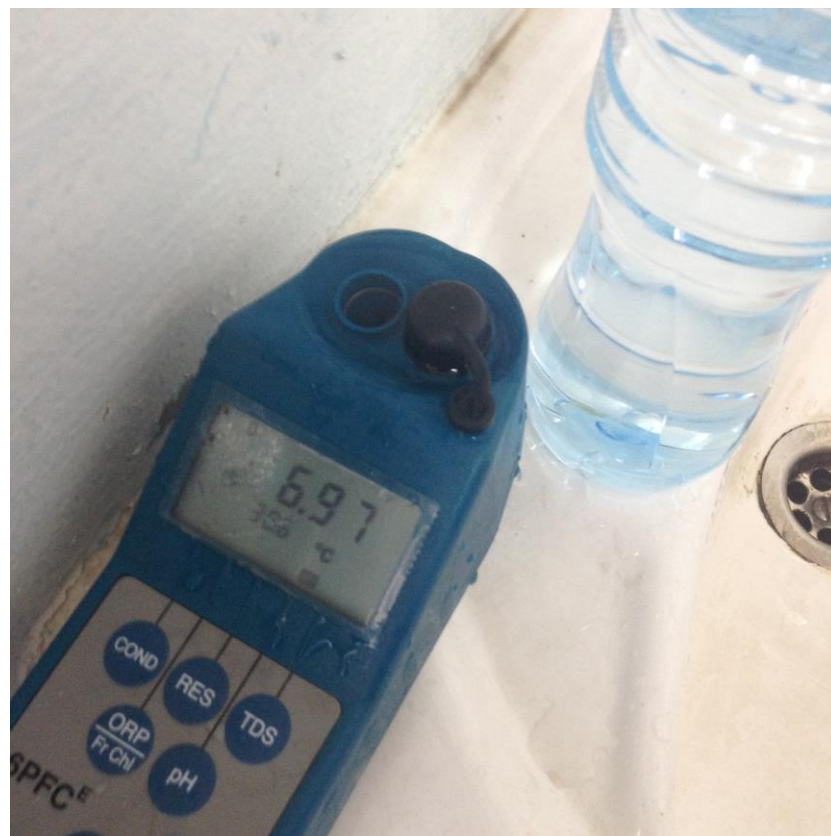
Water TDS Status Kitchen Area

August 10, 2016- with Broxo salt water softener.

August 29, 2016- without chemical water softener; TDS has stable values.

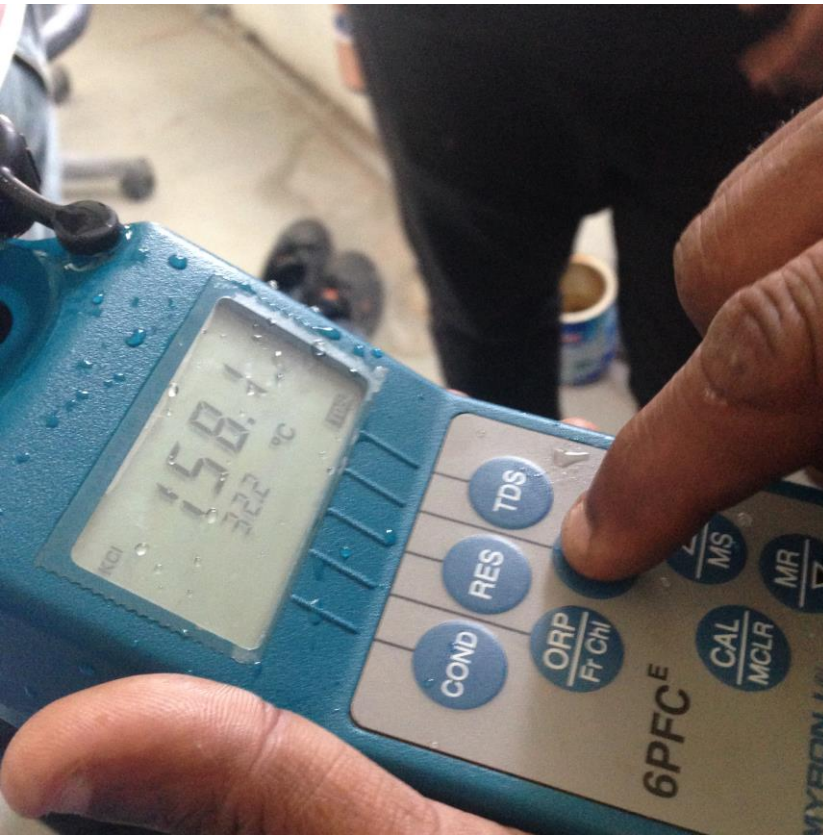
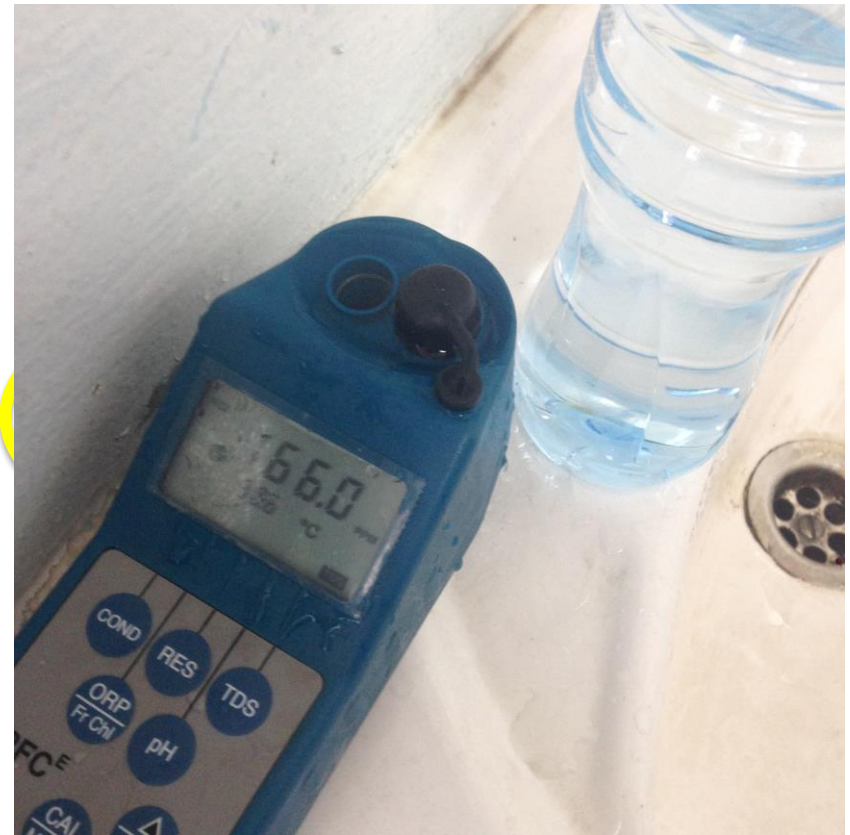
Water pH Status Room 1605

August 10, 2016- with Broxo salt water softener.

August 29, 2016- without chemical water softener; with better pH status.

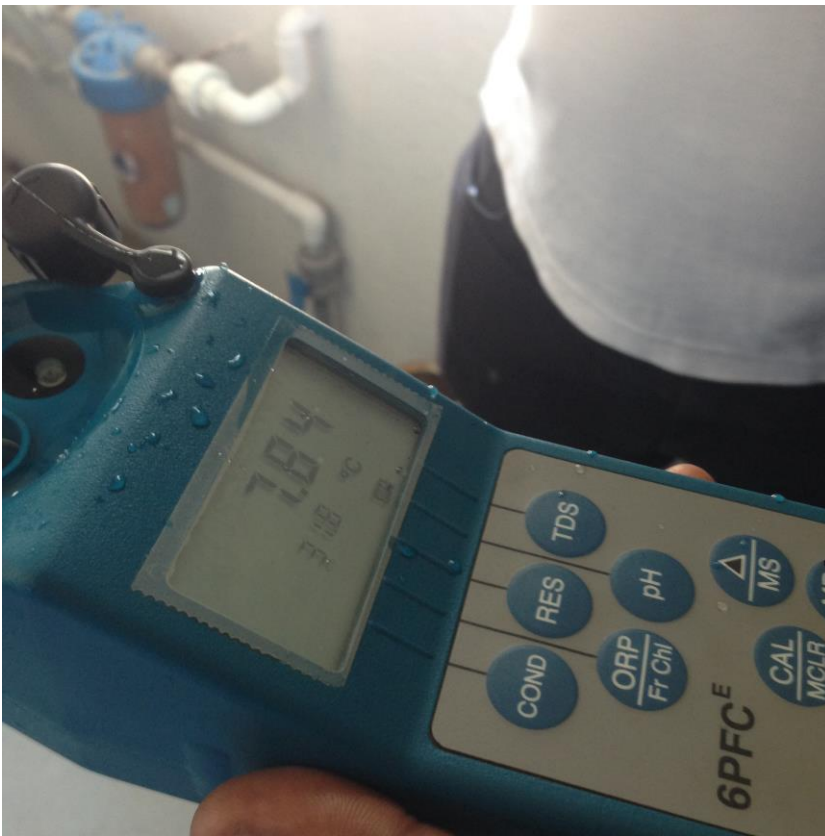
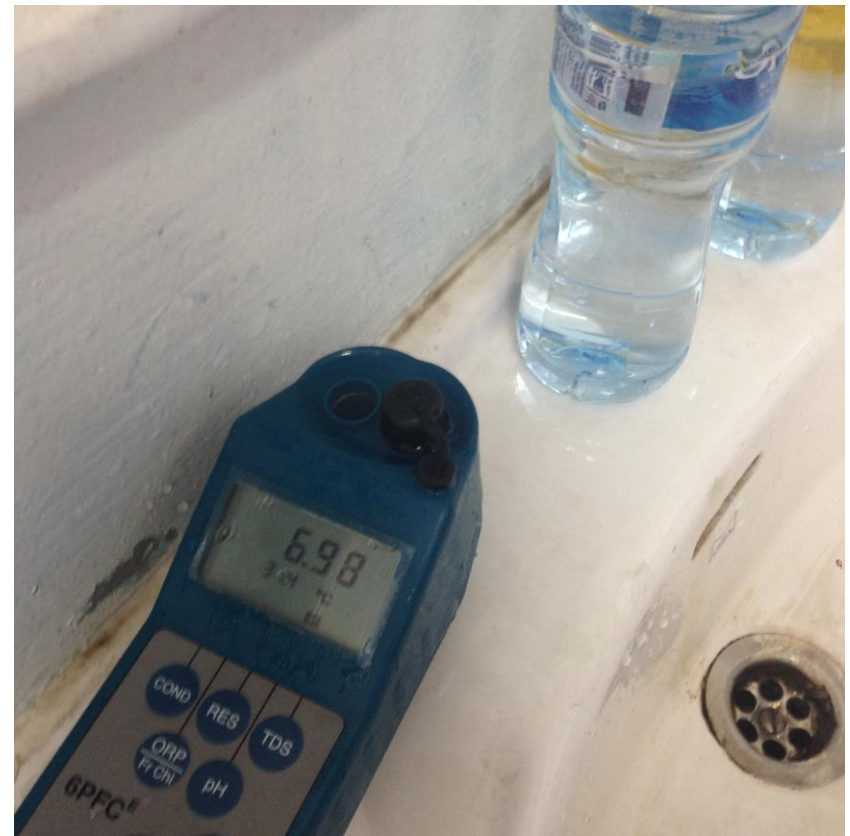
Water TDS Status Room 1605

August 10, 2016- with Broxo salt water softener.

August 29, 2016- without chemical water softener; TDS has stable values.
