ScaleWatcher- Truck Radiator Protection (TRP) System

Case Study Final Monitoring Report

Gulf City Cleaning LLC- Nass Group

November 16, 2016

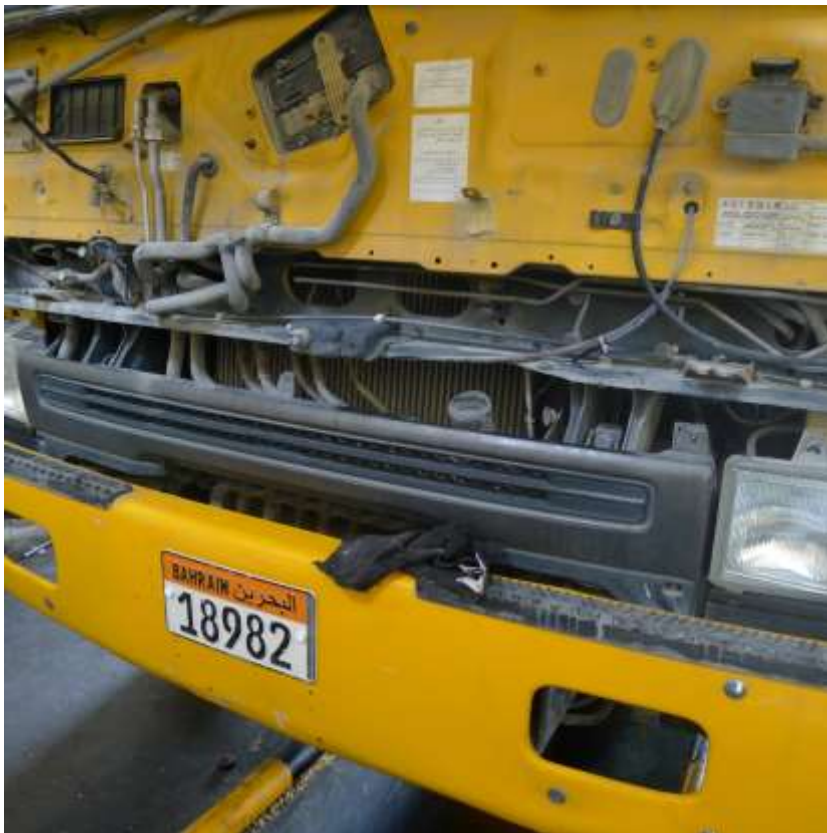
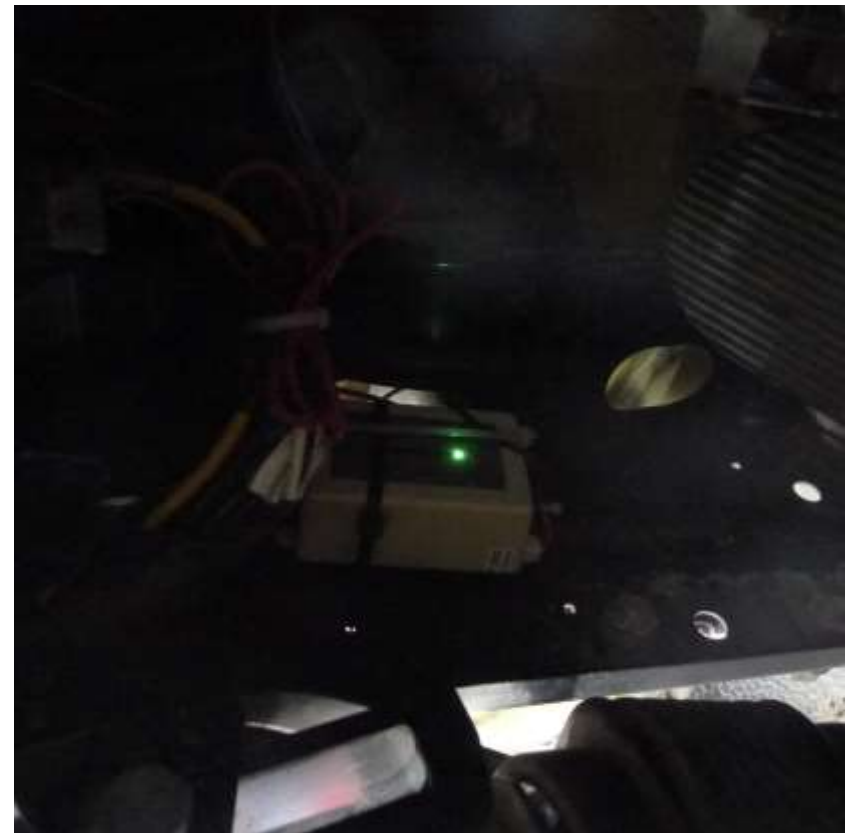
Gulf City Cleaning
Garbage Collection Truck
Plate #18982 Body #642

The SW TRP unit installed just under the pedals of the driver's seat area.

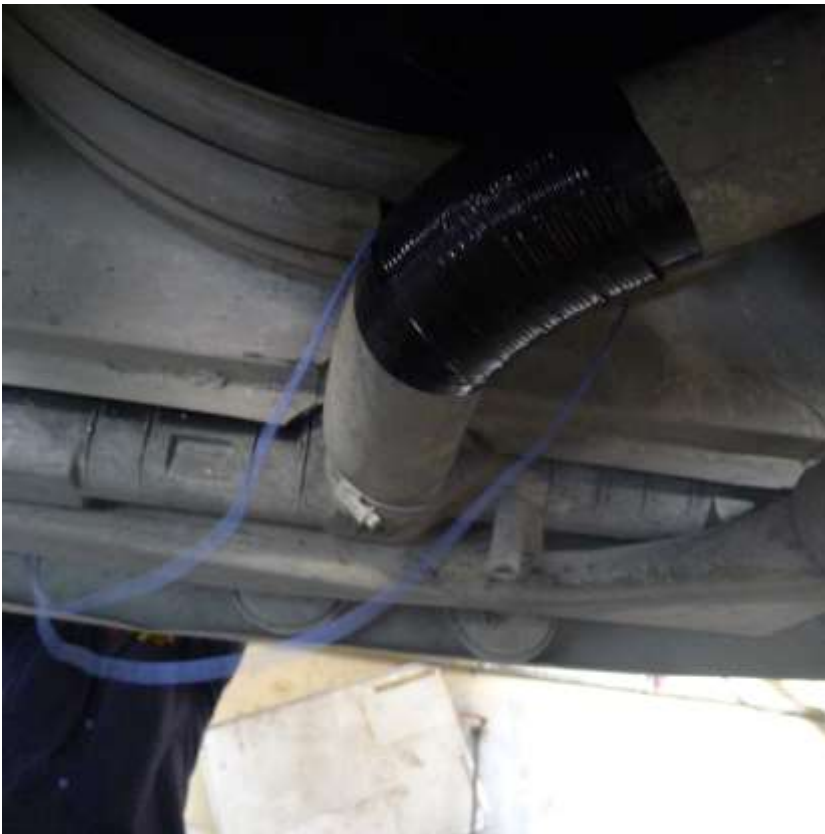
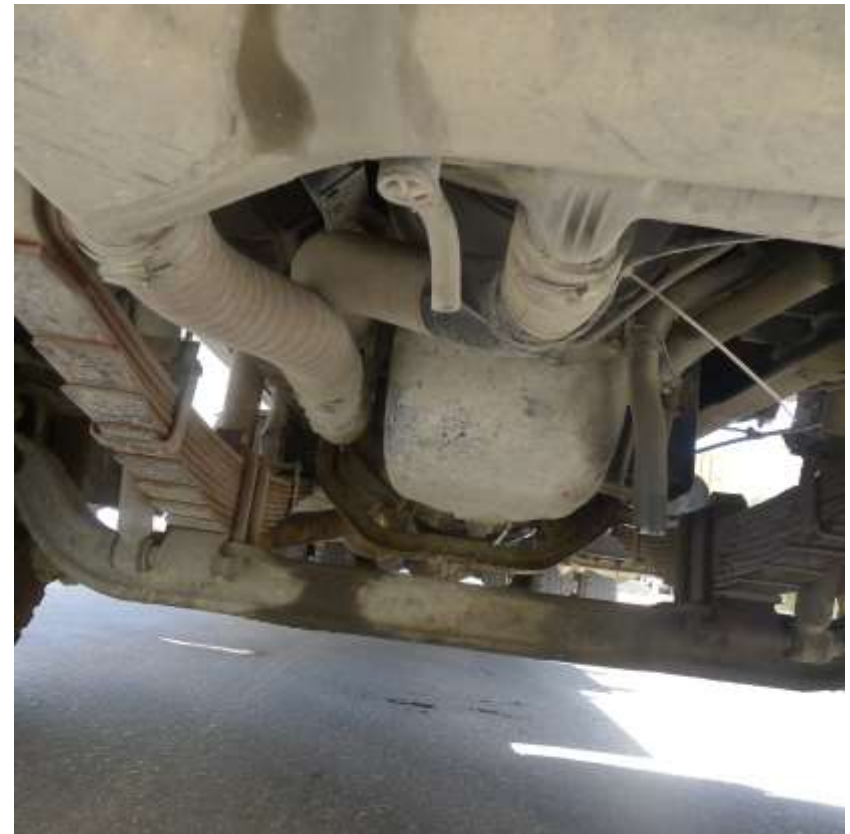
Side by Side Comparison

September 11, 2016- on the day of SW installation.

September 26, 2016- 15 days after installation.

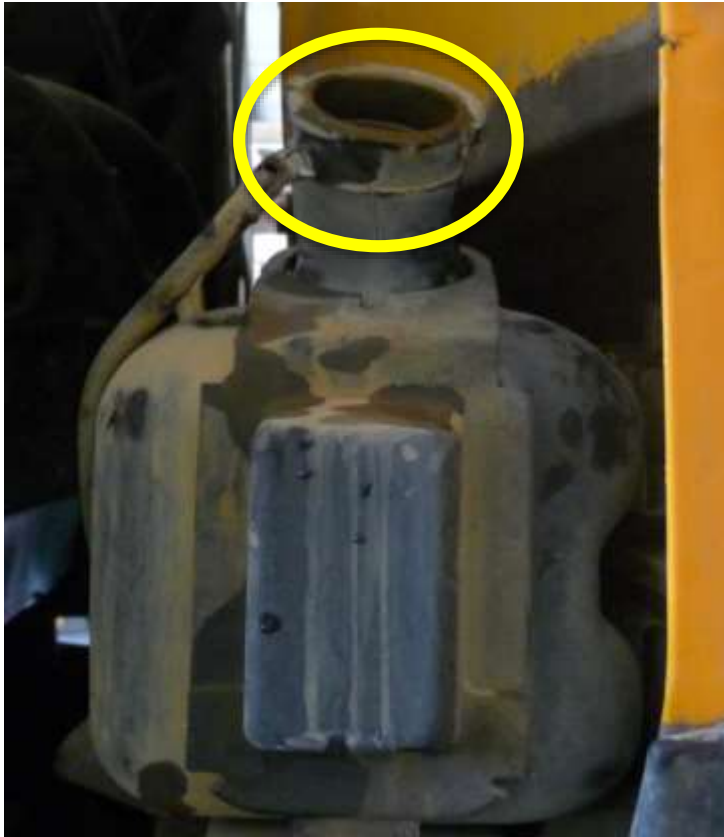
September 11, 2016- Before SW installation. (**Rust** around neck)

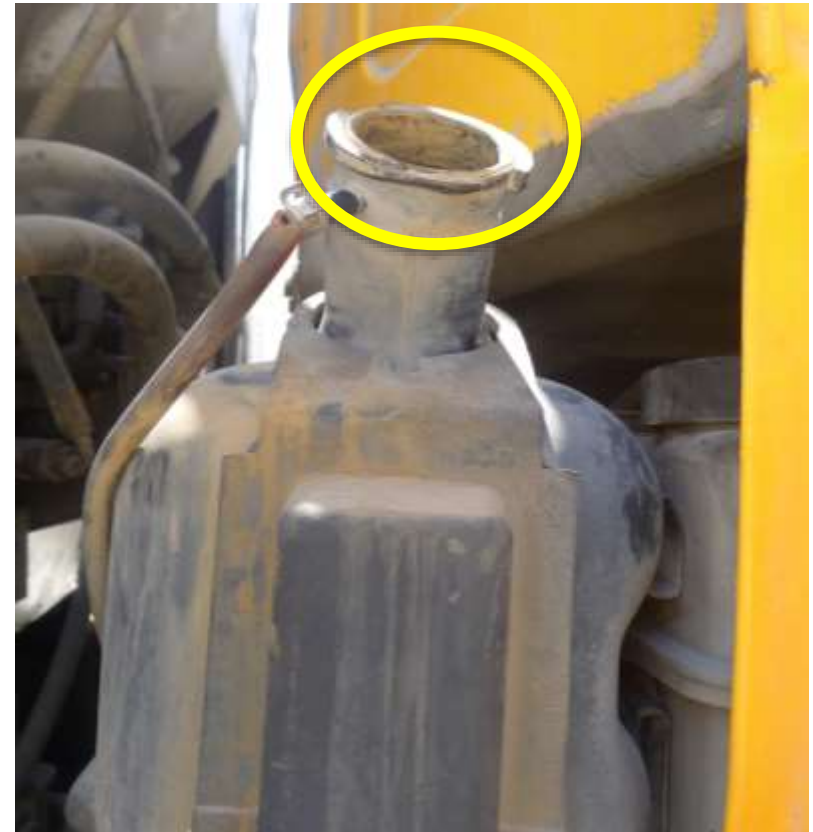
September 26, 2016- 15 days after installation. (**No more rust**)

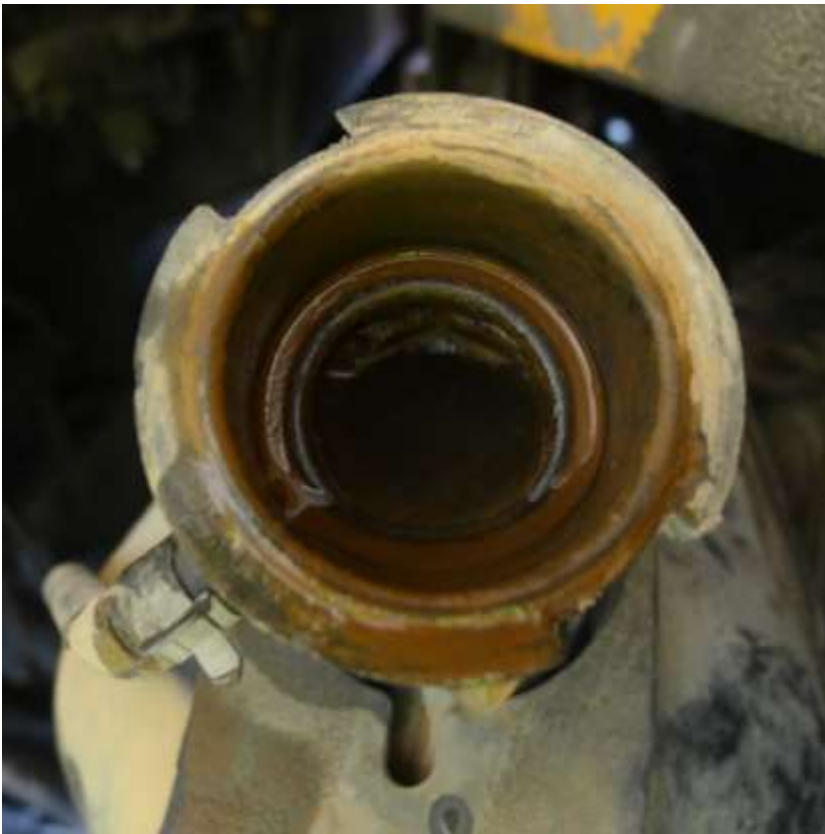
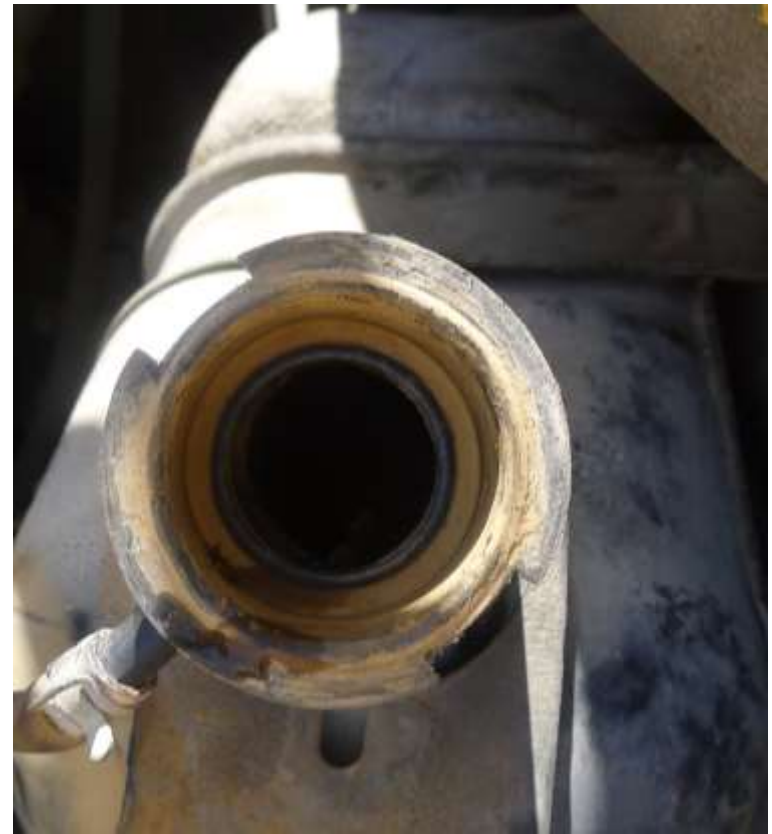
Side by Side Comparison

September 11, 2016- Before SW installation. (**Jammed** system)

September 26, 2016- 15 days after installation. (**Clean** system)

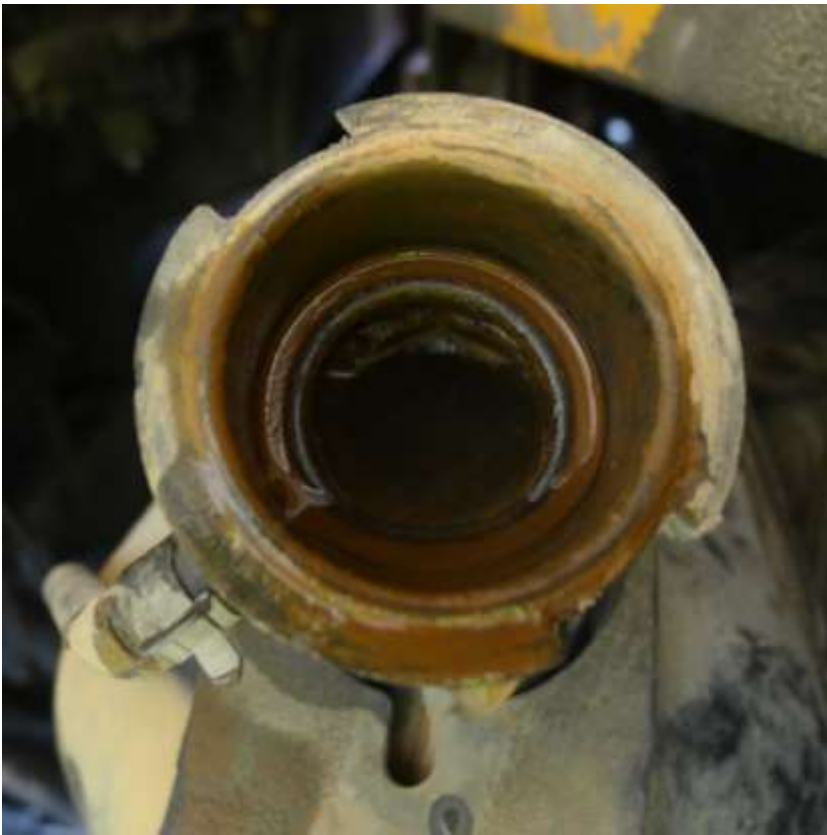
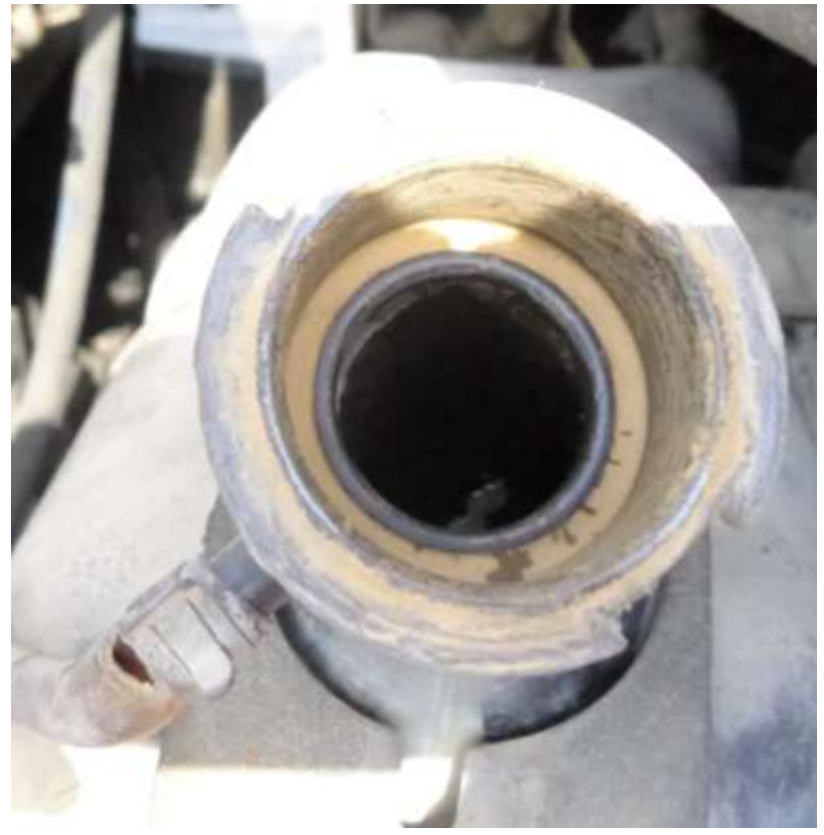
Side by Side Comparison

September 11, 2016- Before SW installation. (**Jammed** system)

October 23, 2016- 43 days after installation. (**Clean** system)

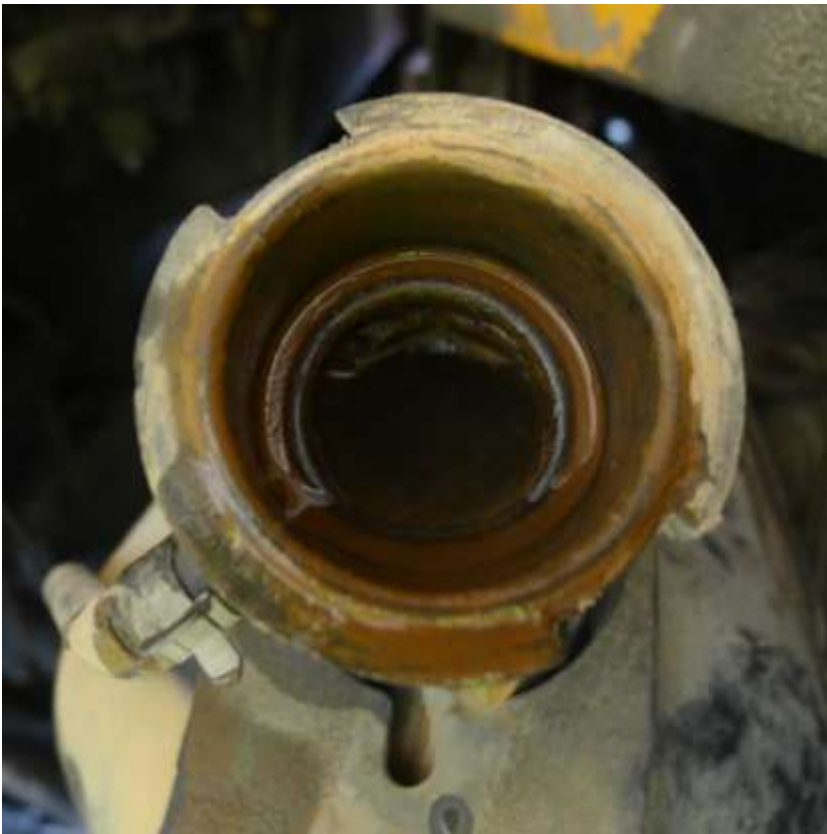
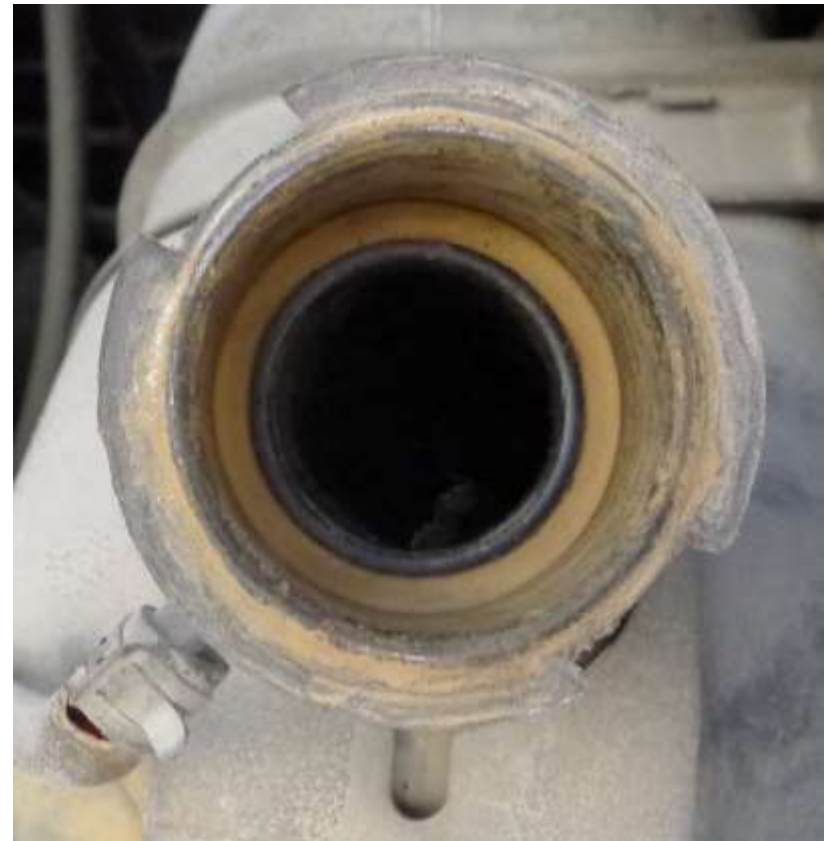
Side by Side Comparison

September 11, 2016- Before SW installation. (**Jammed** system)

November 10, 2016- 60 days after installation. (**Clean** system)

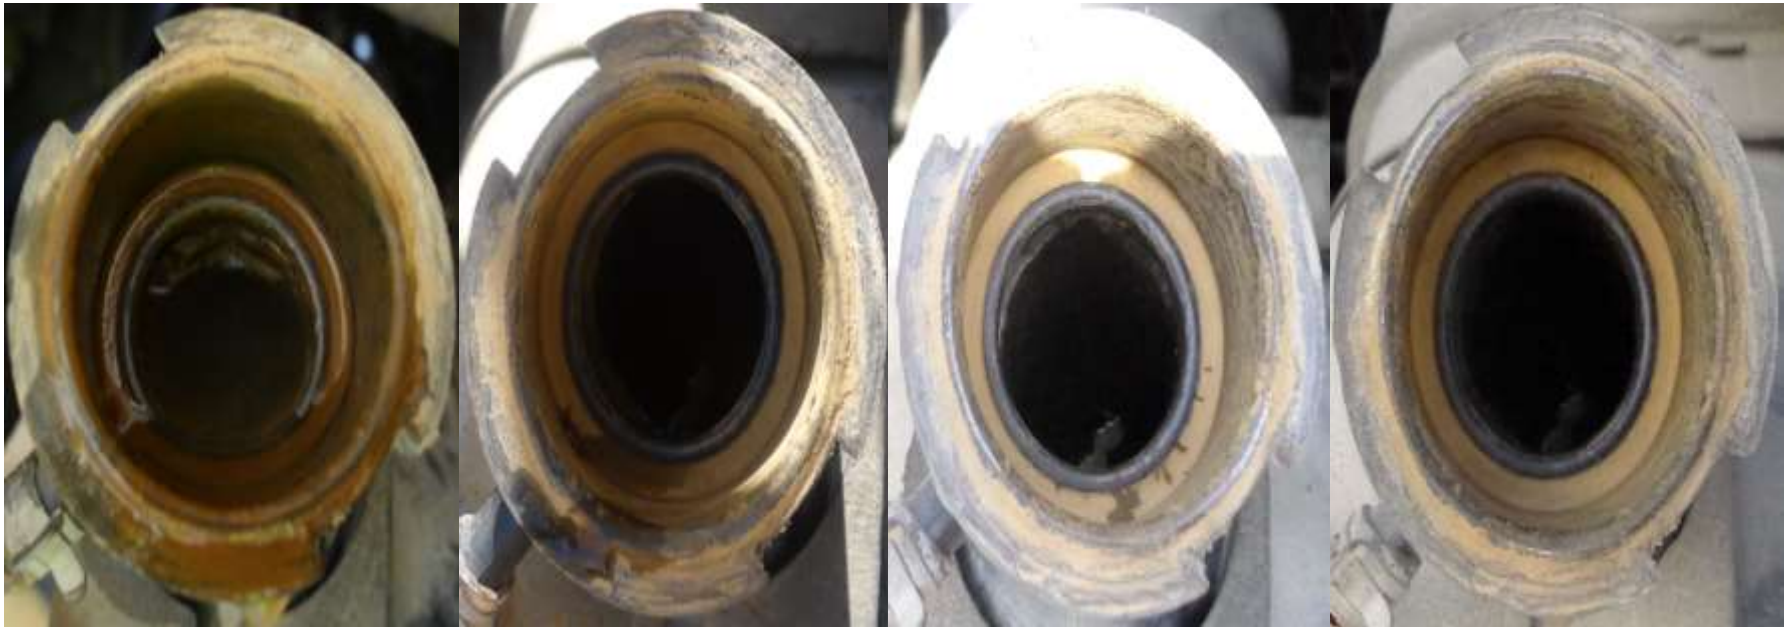
Improvement of the Truck Radiator System from the day of Installation

0 day (**Bad**)

15th day (**Good**)

43rd day (**Better**)

60th day (**Best**)

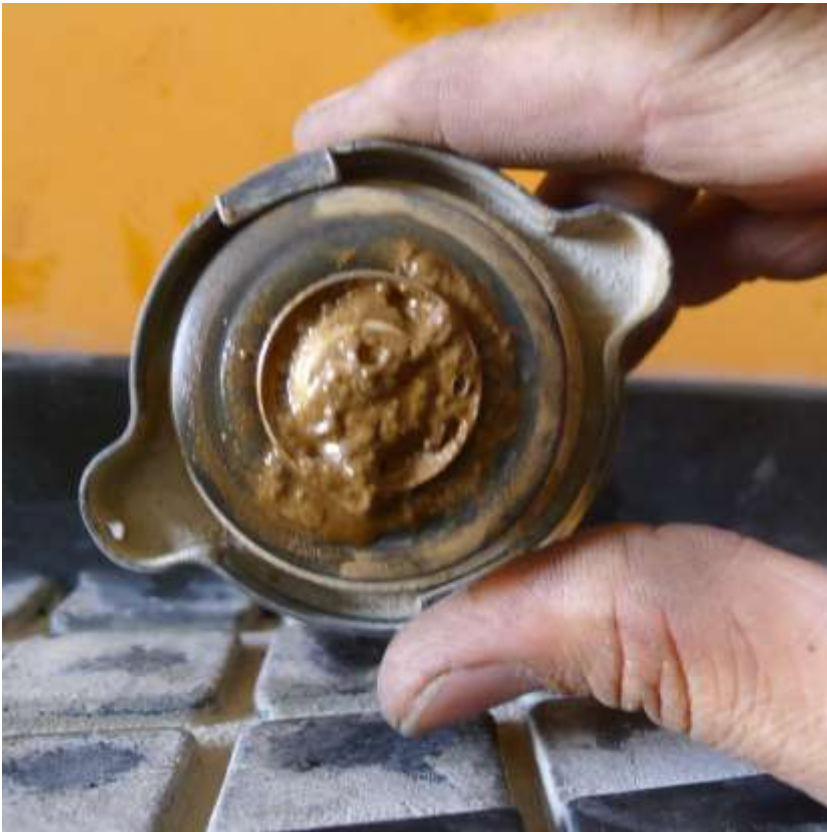
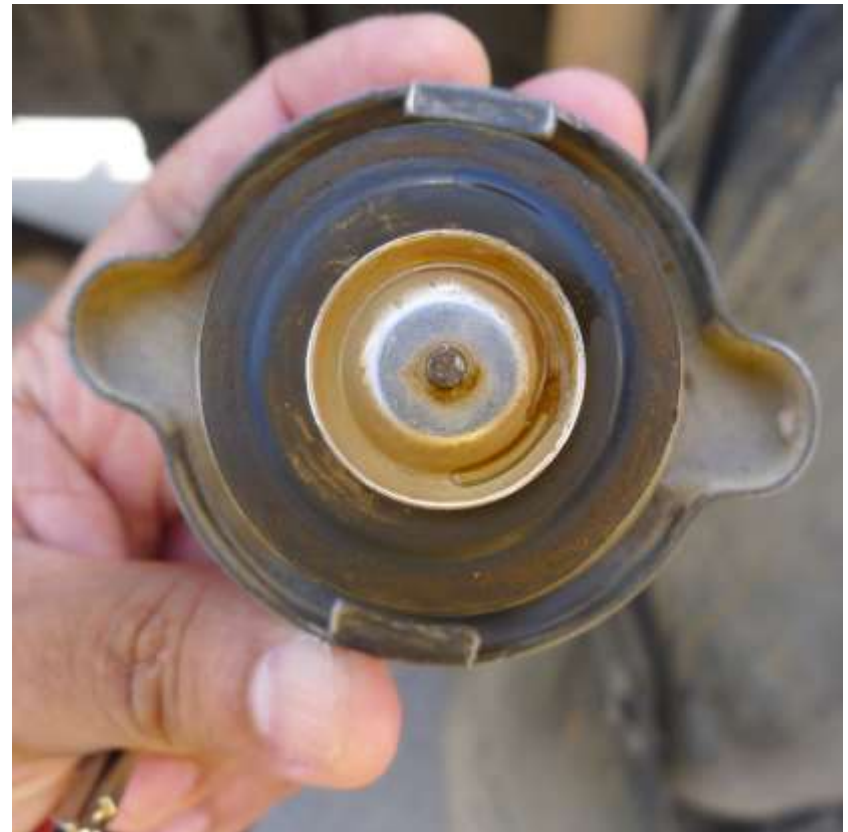
Side by Side Comparison

September 11, 2016- Before SW installation. (**Muddy**)

September 26, 2016- 15 days after installation. Actual status of the radiator cap directly after taking it off from the reservoir. (**Clean**)

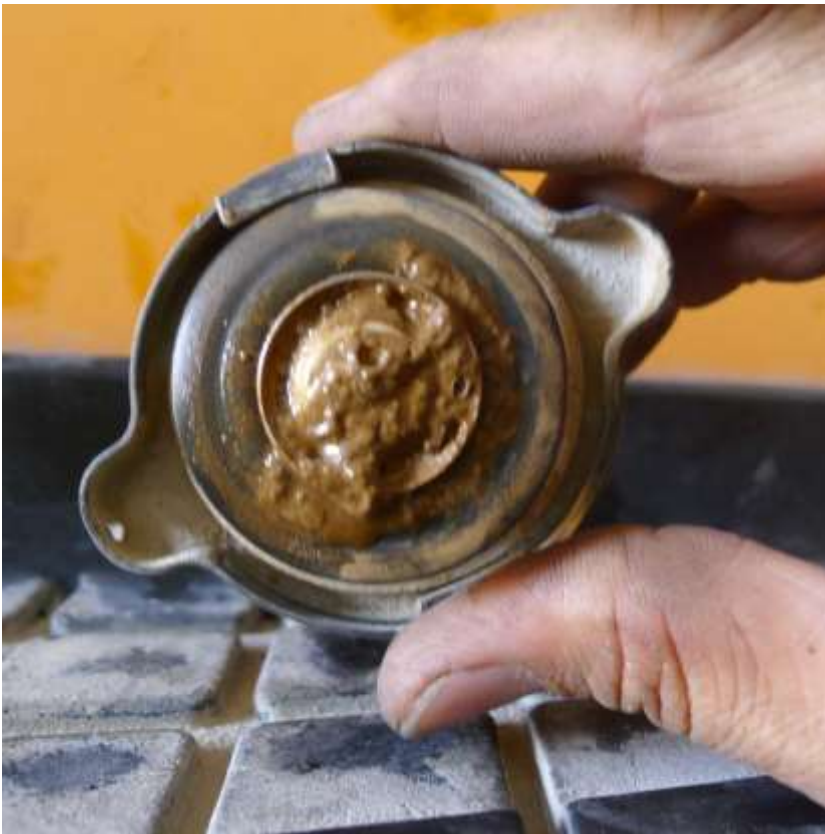
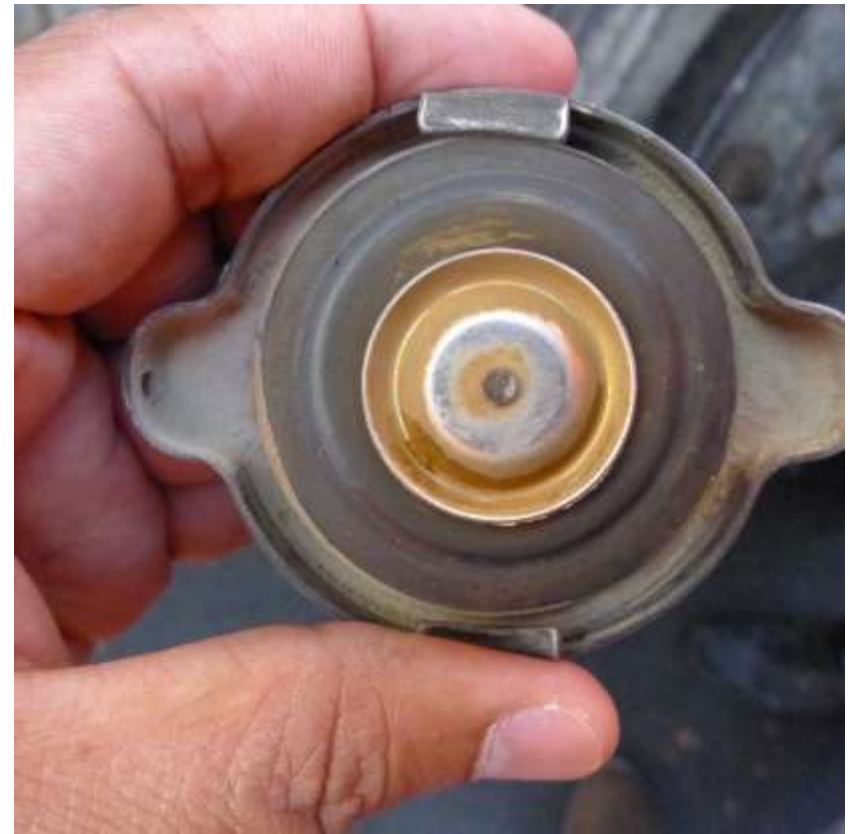
Side by Side Comparison

September 11, 2016- Before SW installation. (**Muddy**)

October 23, 2016- 43 days after installation.
Actual status of the radiator cap directly after taking it off from the reservoir.

(**Clean**)

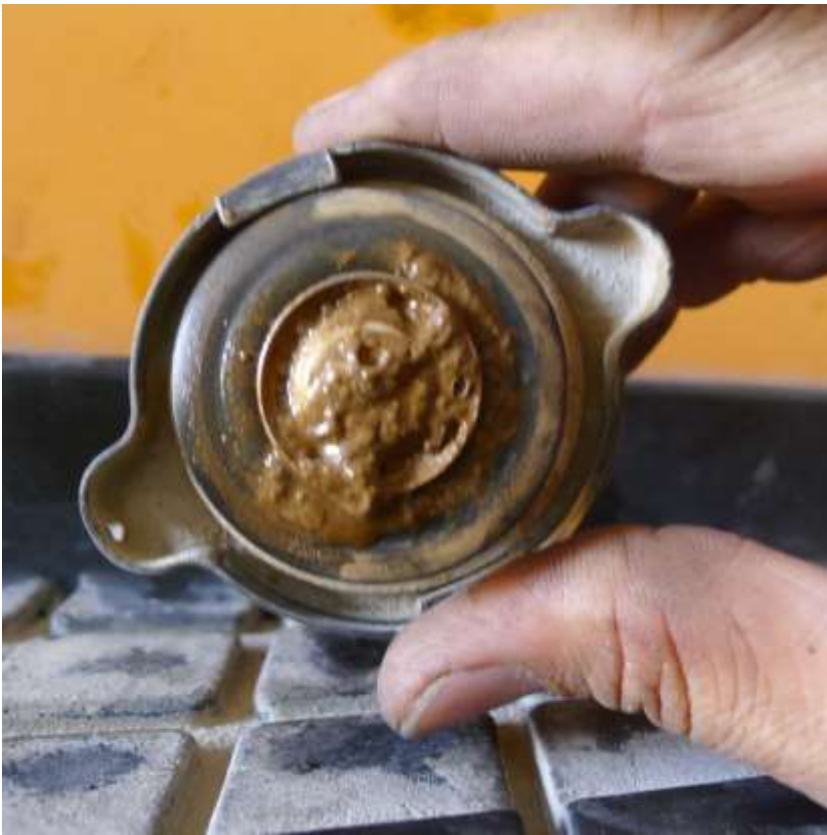
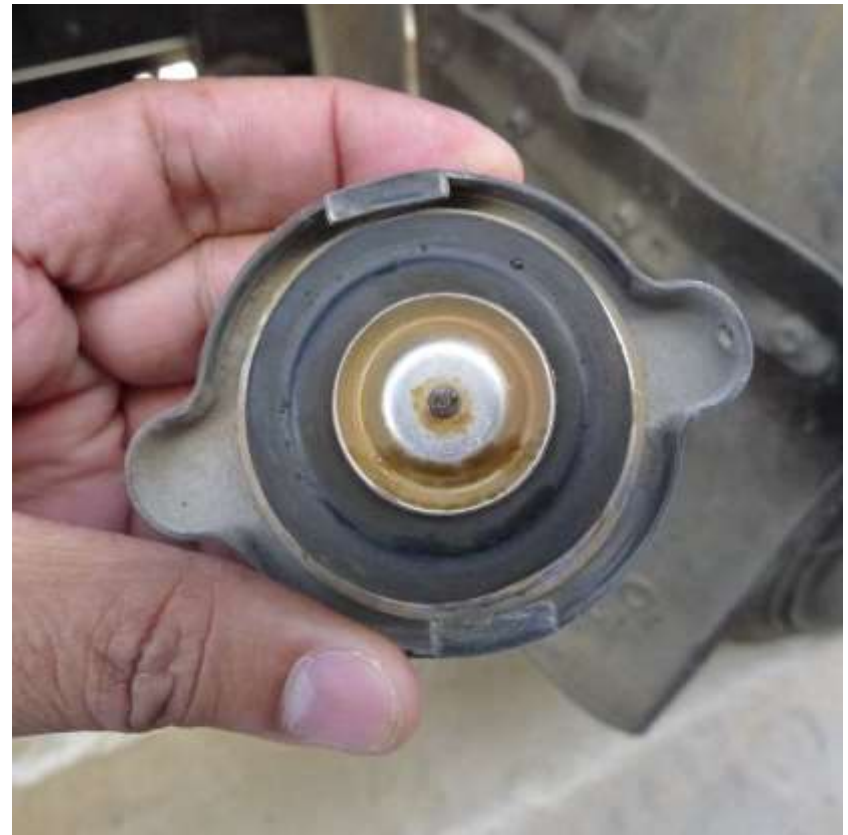
Side by Side Comparison

September 11, 2016- Before SW installation. (**Muddy**)

November 10, 2016- 60 days after installation. Actual status of the radiator cap directly after taking it off from the reservoir. (**Cleaner**)

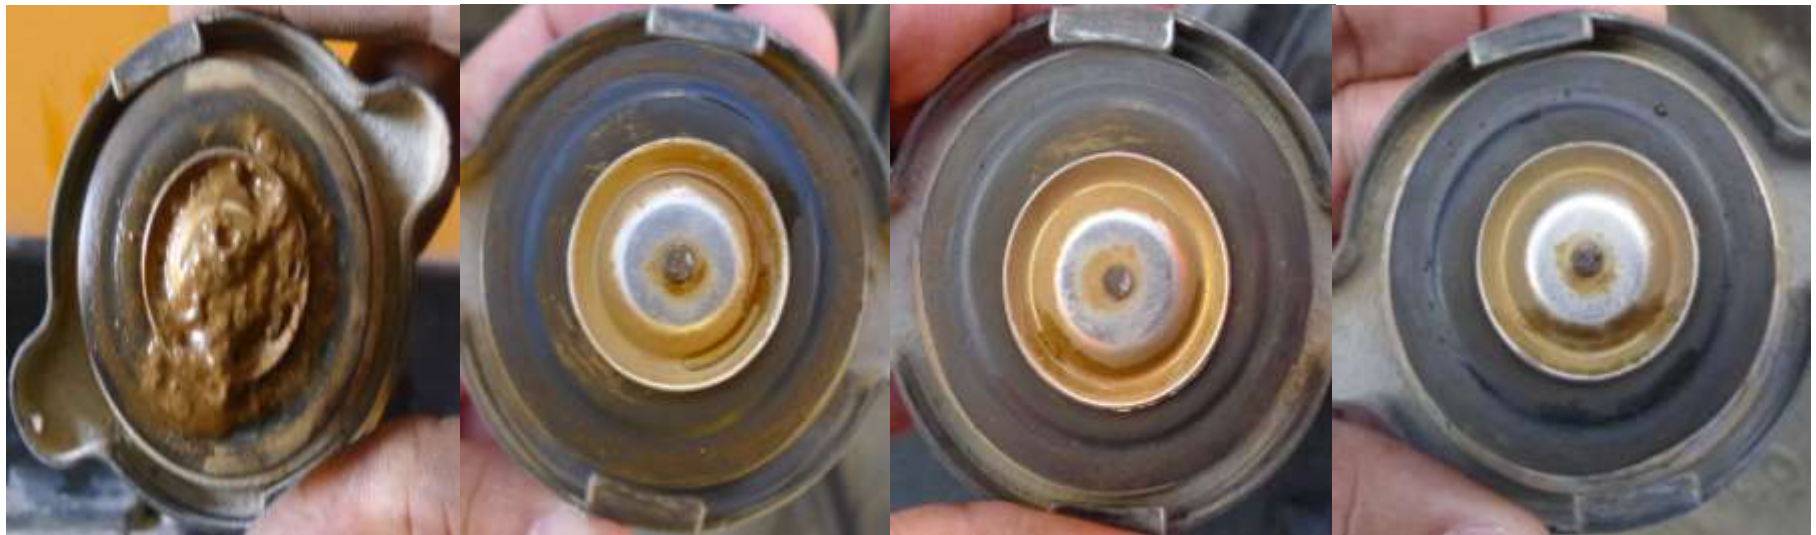
Improvement of the Truck Radiator System from the day of Installation

0 day (**Bad**)

15th day (**Good**)

43rd day (**Better**)

60th day (**Best**)

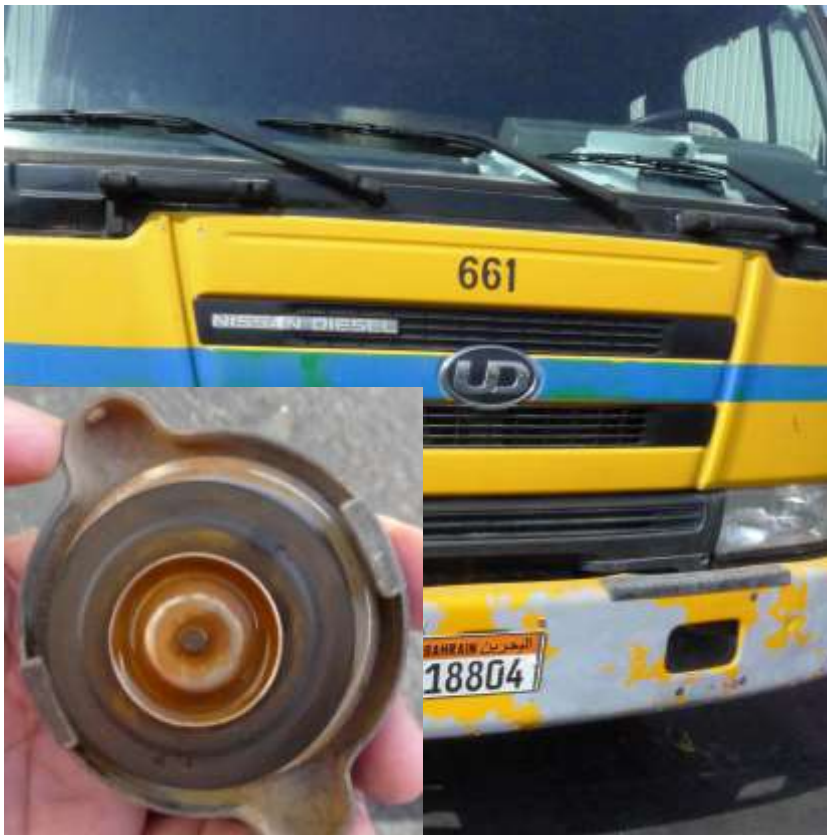
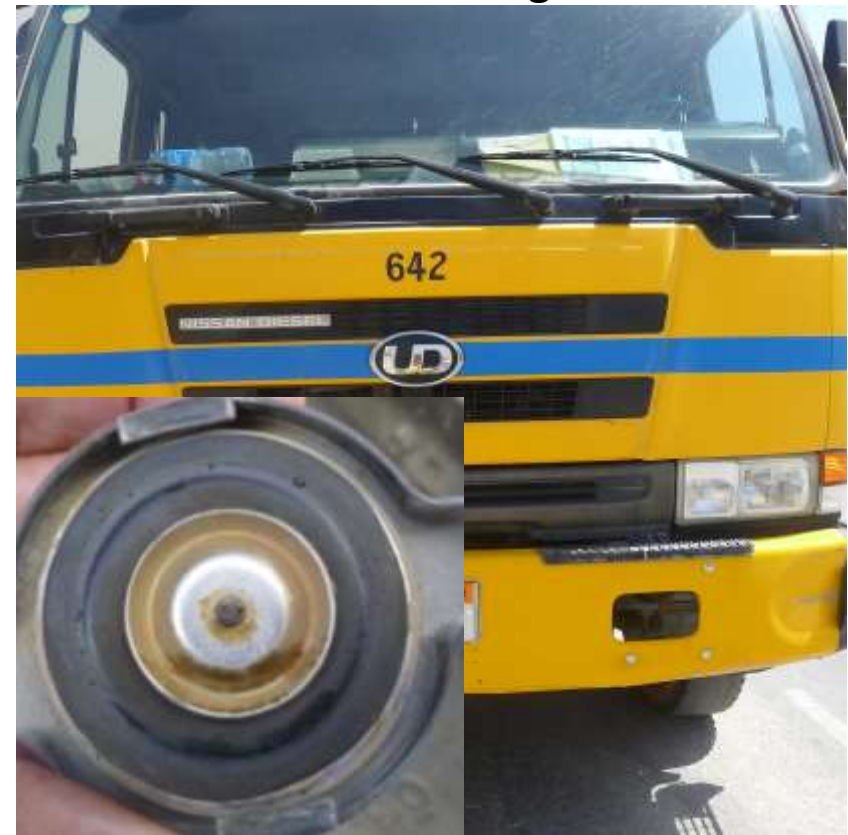
Side by Side Comparison: Trucks without and with SW-TRP System

Truck #661 **without SW** TRP system:
indicating a rusty radiator sludge

Truck #642 **with SW** TRP system for 60 days:
radiator cap and circulating water
indicating 80% reduction of rusty
radiator sludge.

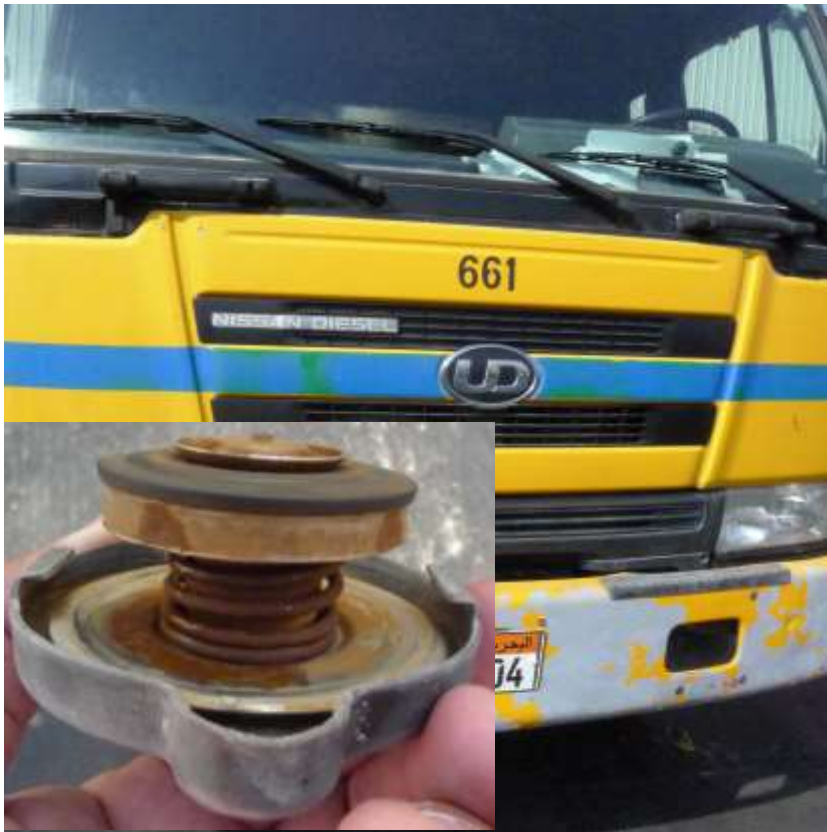
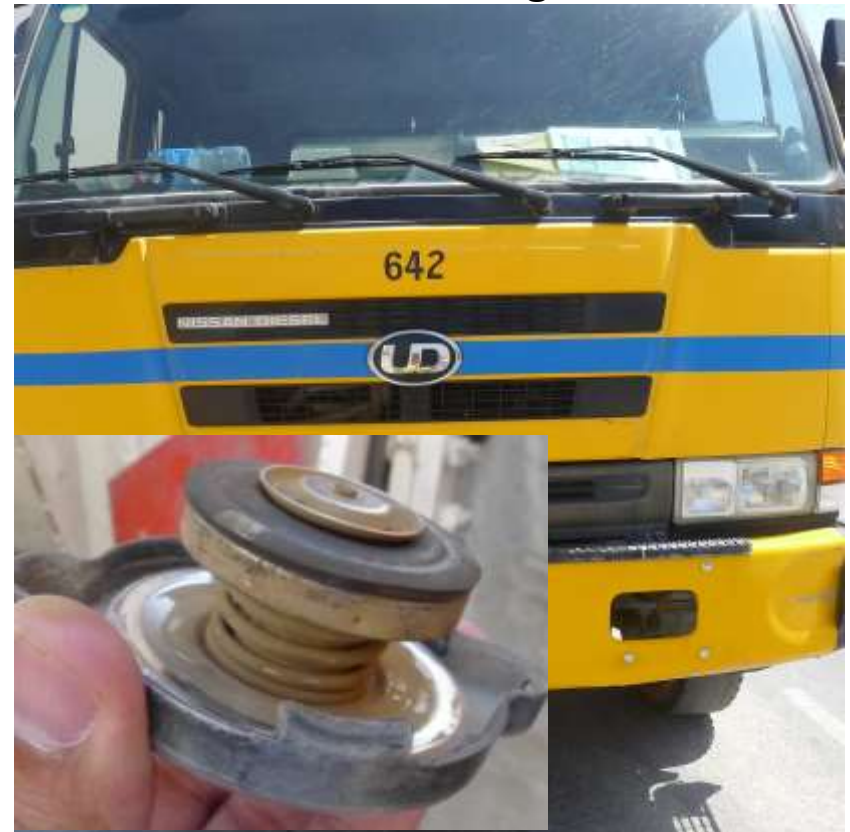
Side by Side Comparison: Trucks without and with SW-TRP System

Truck #661 **without SW** TRP system:
indicating a rusty radiator sludge

Truck #642 **with SW** TRP system for 60 days:
radiator cap and circulating water
indicating 80% reduction of rusty
radiator sludge.
