Final Monitoring Report

Marriotts Diplomatic Quarters - Riyadh Kingdom of Saudi Arabia

ScaleWatcher (SW) Water Treatment Report for the
dishwashers and laundry systems, 24th November 2022.

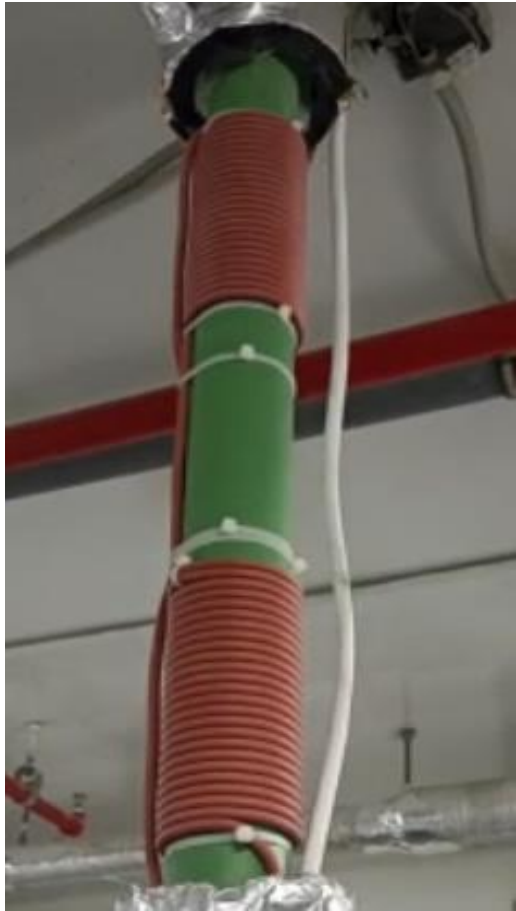
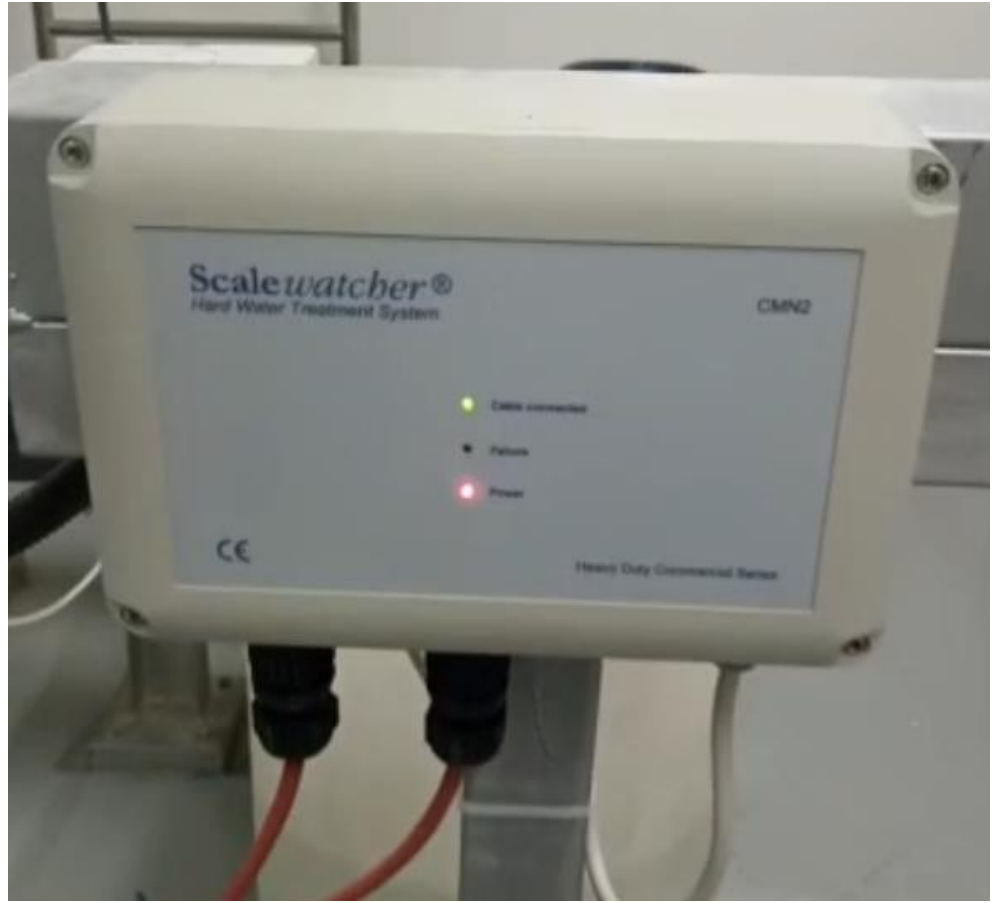
SW Heavy Duty Commercial Model installed in the 2" inlet pipe of the water system going to kitchen and laundry with 2 sets of coil of 25 loops separated by 20 cm distance.

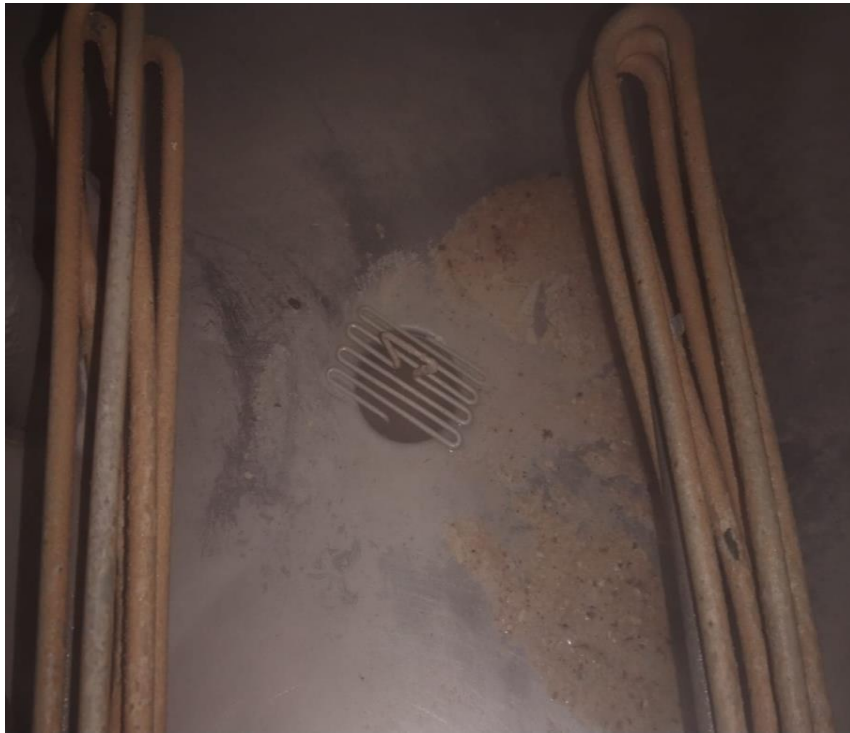
Before treatment (24th Nov. 2022), as shown in the image, the surface is dull and rough due to the scale layers present on it

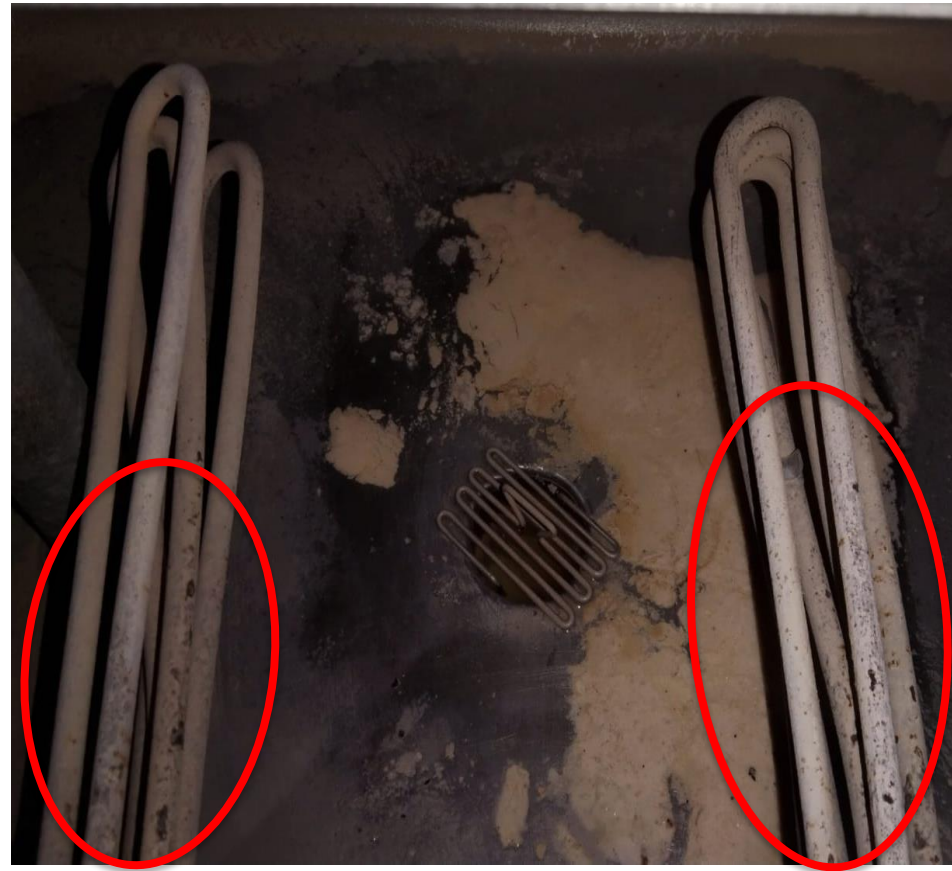
After treatment (week 1), the image clearly shows that the surface is losing scaling at some spots

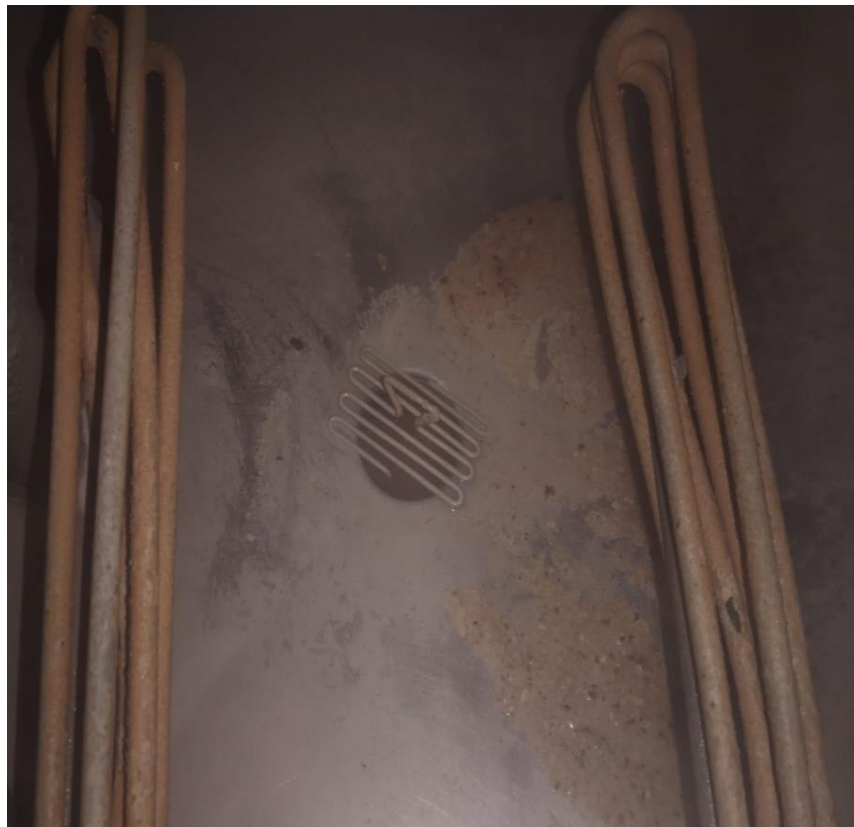
Before treatment (24th Nov. 2022), as shown in the image, the surface is dull and rough due to the scale layers present on it

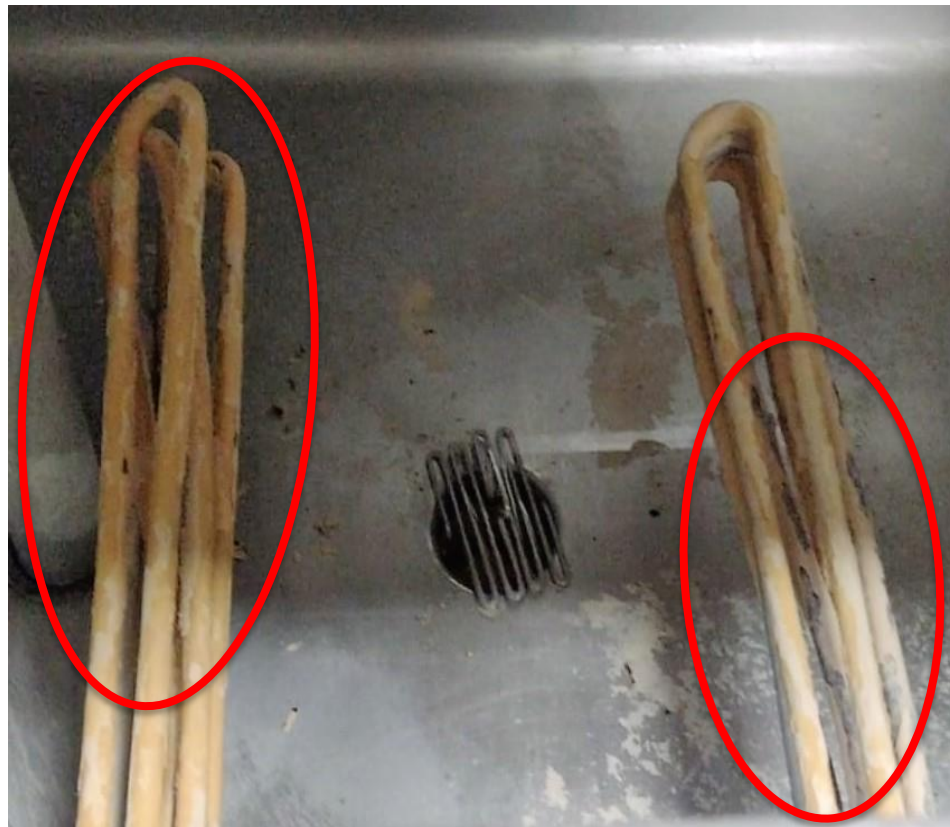
After treatment (week 2), the image clearly shows that the surface is losing scaling at some spots. Also some scaling pieces are fallen down on sink

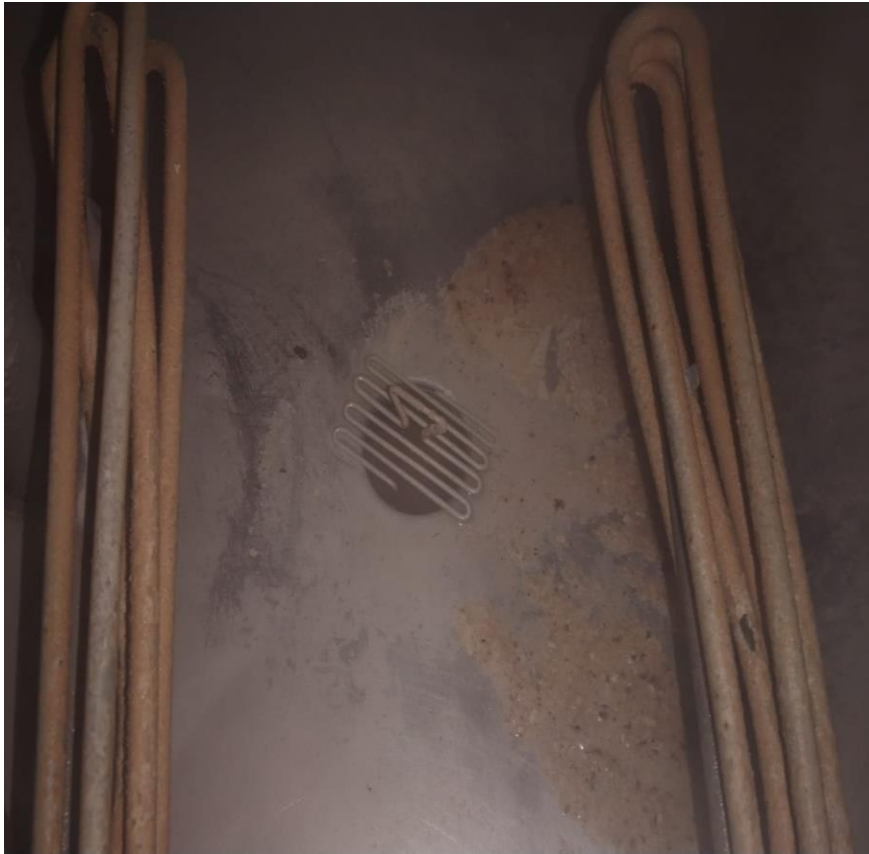
Before treatment (24th Nov. 2022), as shown in the image, the surface is dull and rough due to the scale layers present on it

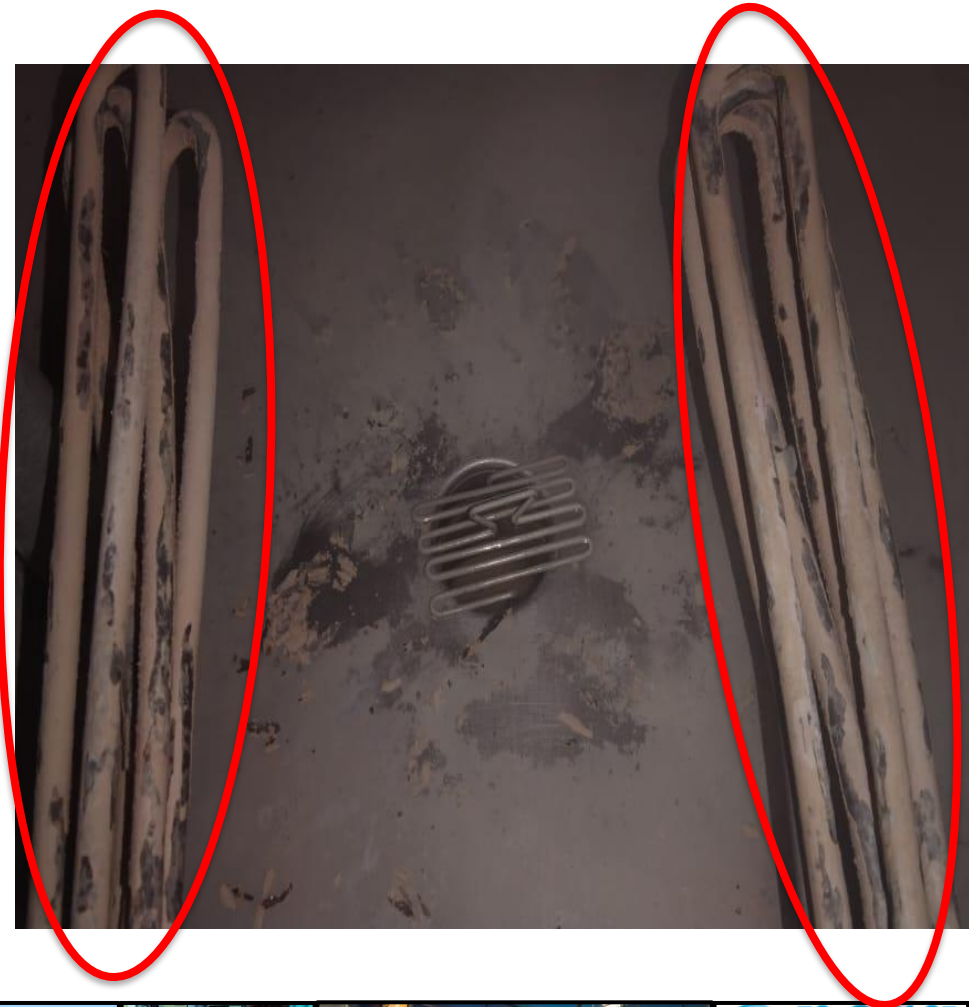
After treatment (Week 3), the image clearly shows that the surface is losing scaling at more spots

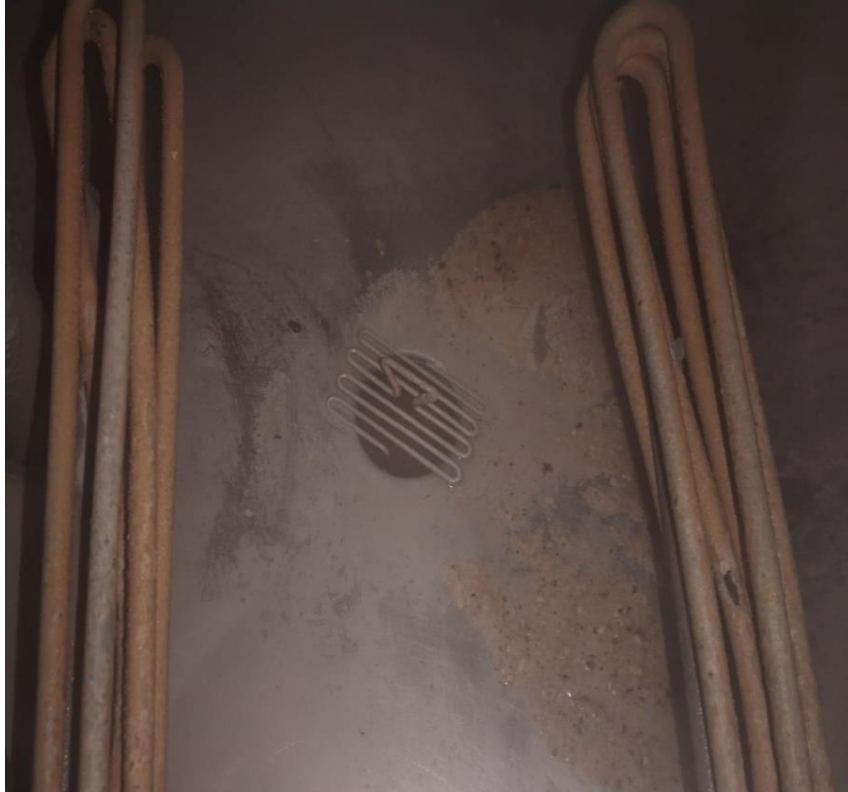
Before treatment (24th Nov. 2022), as shown in the image, the surface is dull and rough due to the scale layers present on it

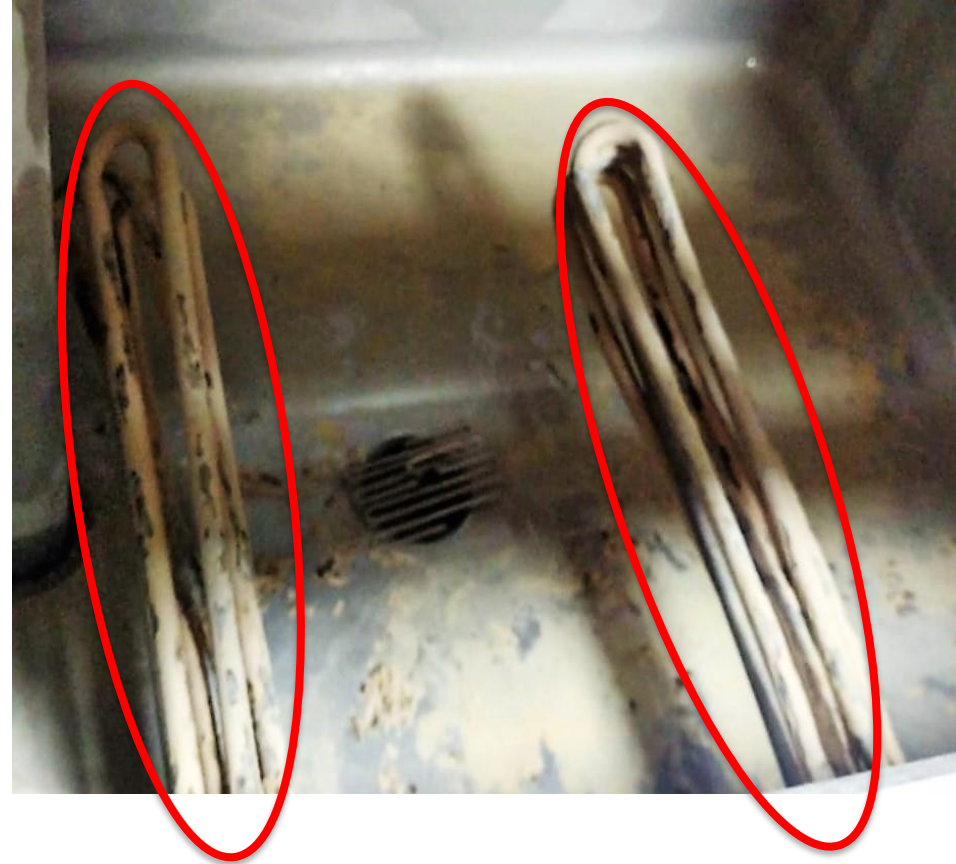
After treatment (week 4), the image clearly shows that the surface is losing scaling at many spots and also lots of scaling pieces are removed and fallen on the sink in the background

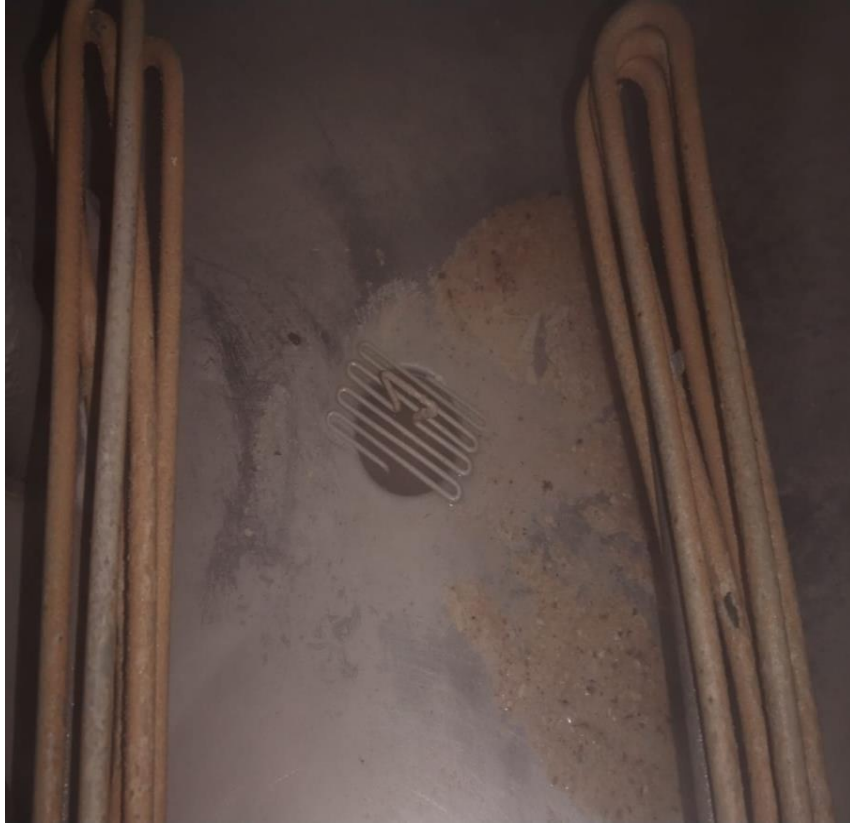
Before treatment (24th Nov. 2022), as shown in the image, the surface is dull and rough due to the scale layers present on it

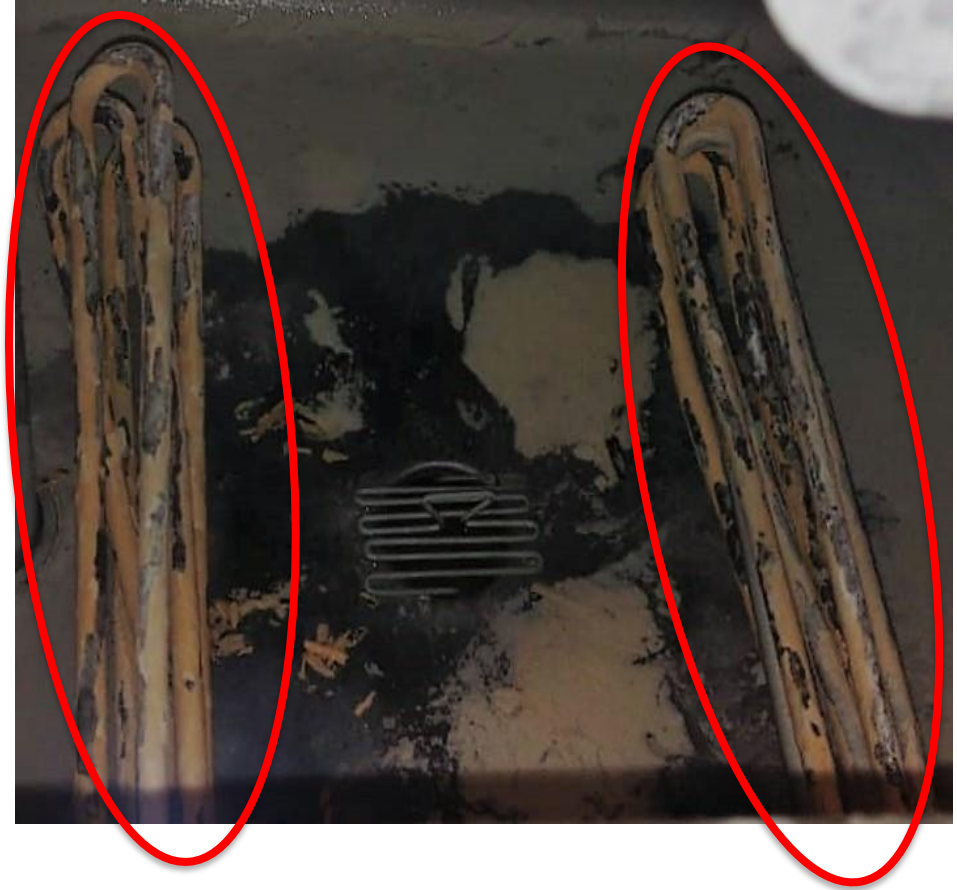
After treatment (week 5), the image clearly shows that the surface is losing scaling at major spots and the sink scaling is also removed partially

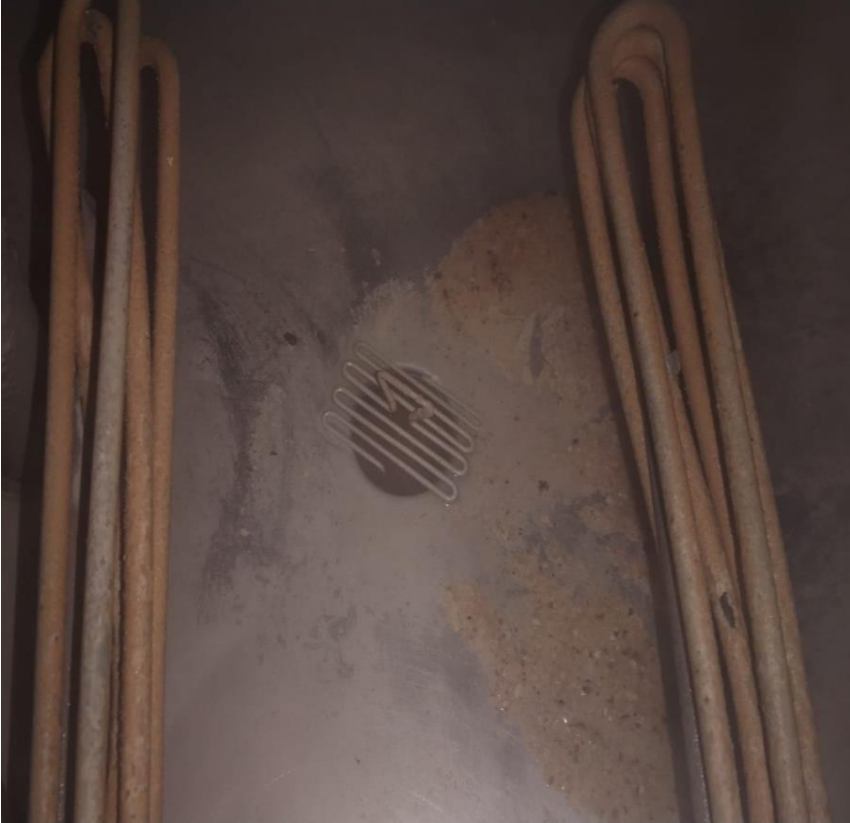
Before treatment (24th Nov. 2022), as shown in the image, the surface is dull and rough due to the scale layers present on it

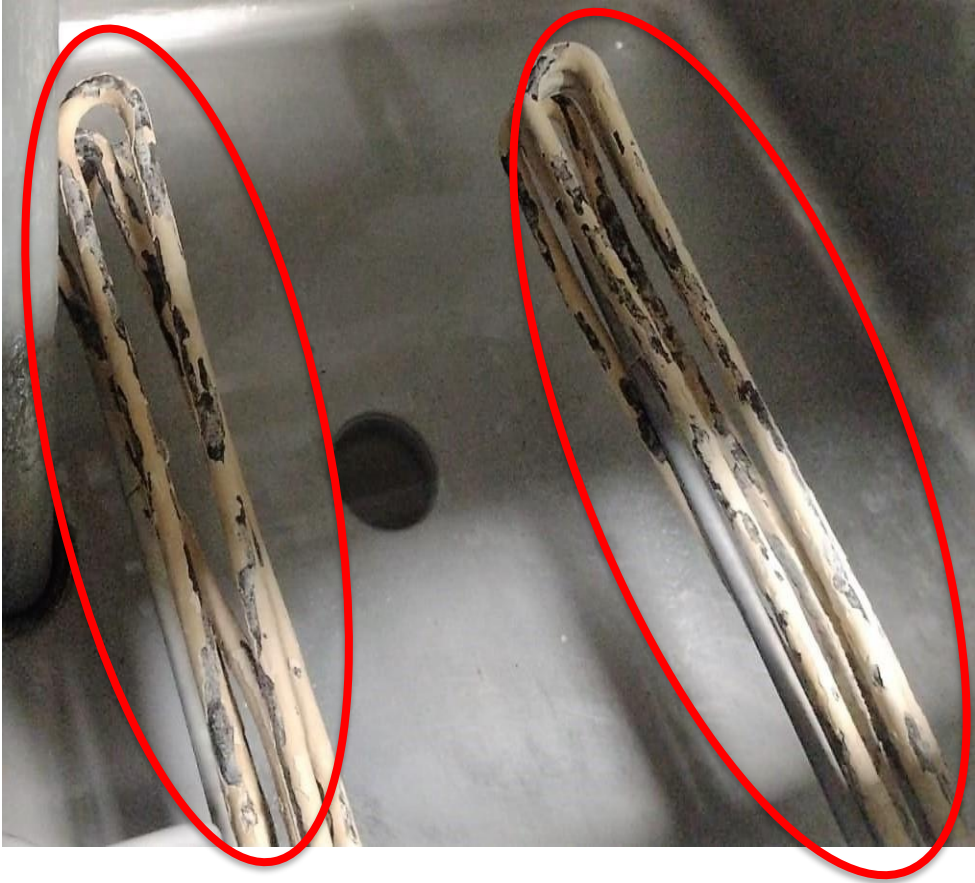
After treatment (week 6), the image clearly shows that the surface is losing scaling at most of spots and also the sink in background looks pretty clean

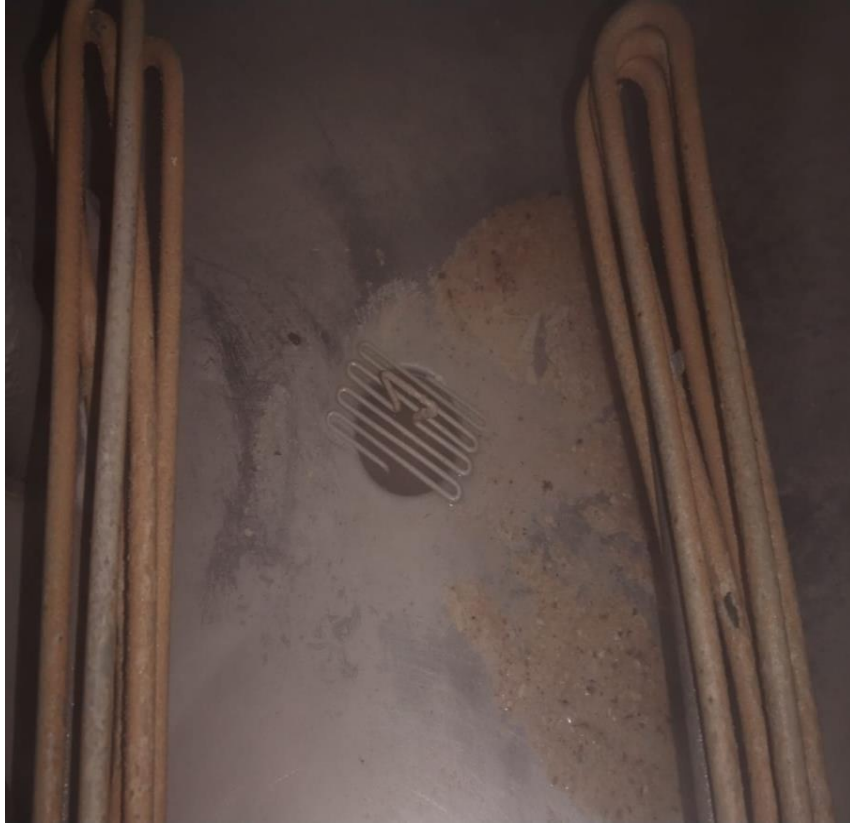
Before treatment (24th Nov. 2022), as shown in the image, the surface is dull and rough due to the scale layers present on it

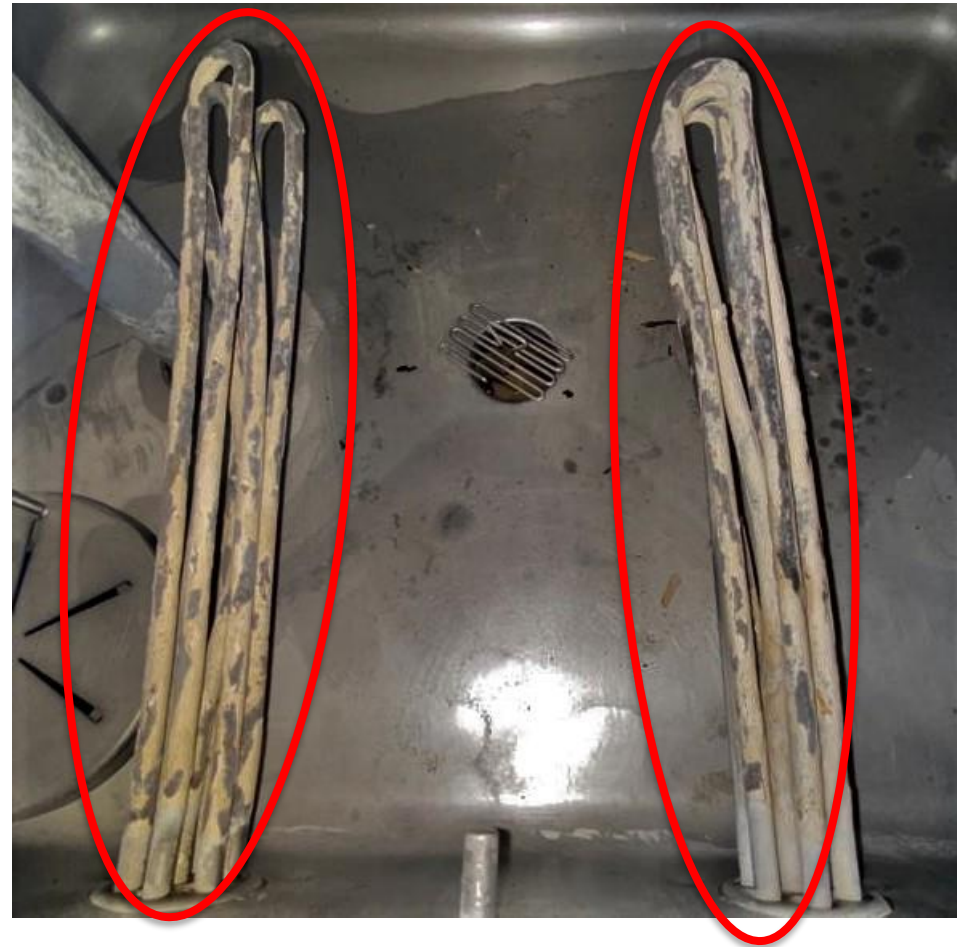
After treatment (week 7), the image clearly shows that the surface is losing scaling at most of spots and also the sink in background looks pretty clean

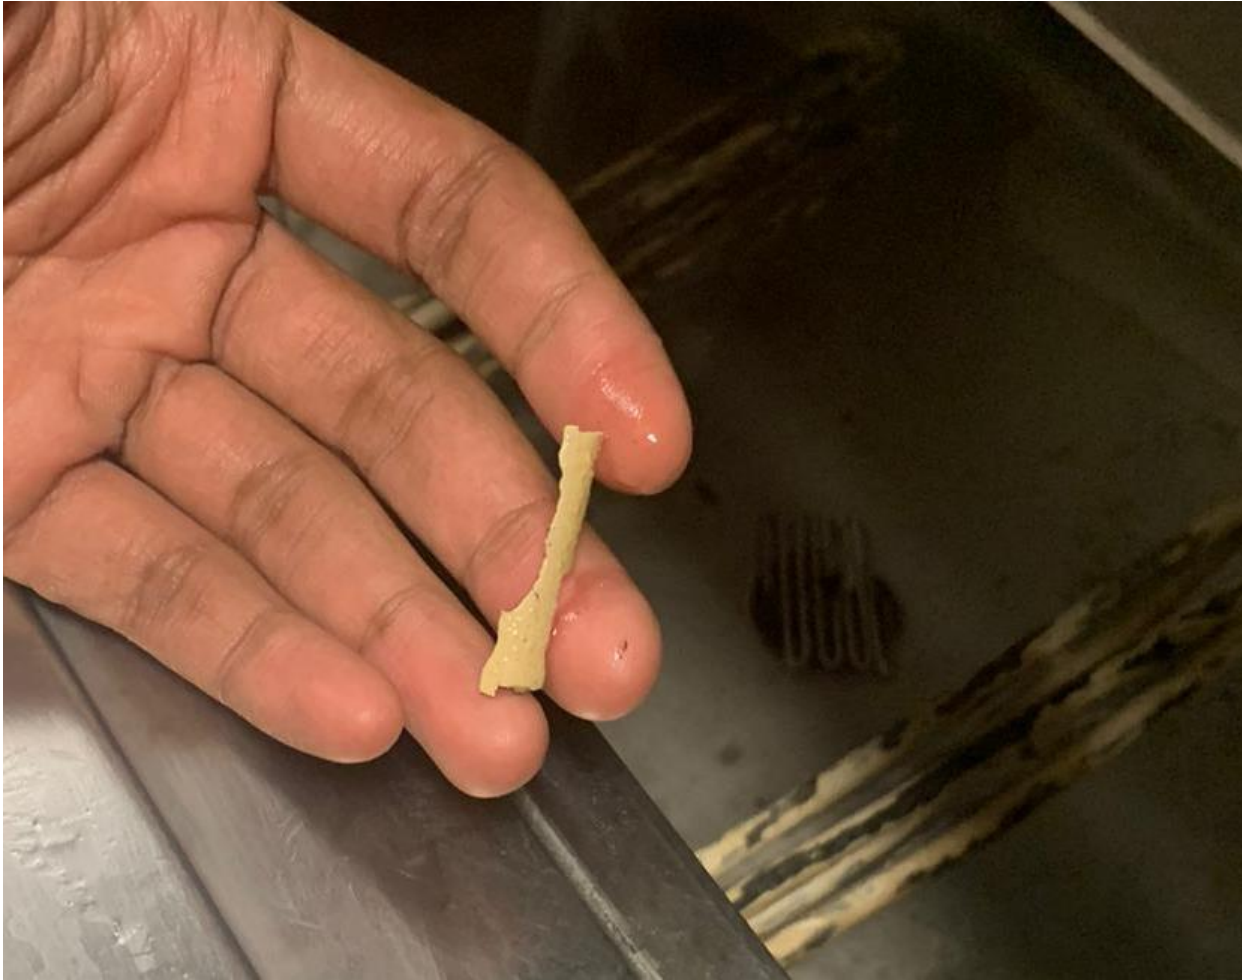
Scaling particles falling of the heating element after 7 weeks of Scalewatcher water treatment

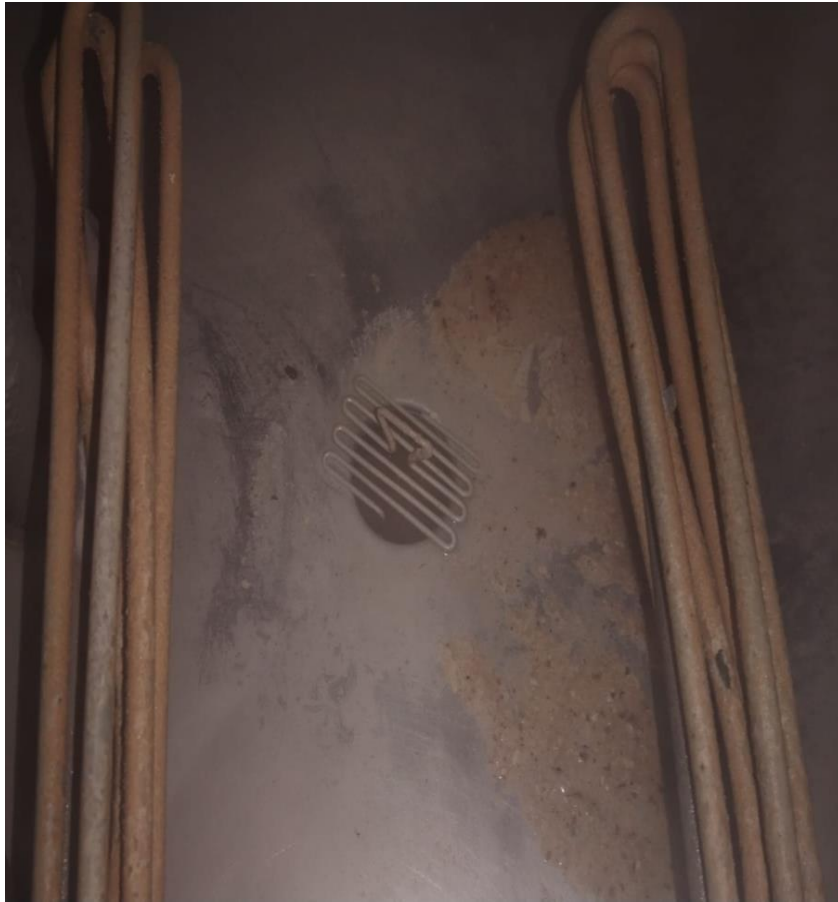
Before treatment (24th Nov. 2022), as shown in the image, the surface is dull and rough due to the scale layers present on it

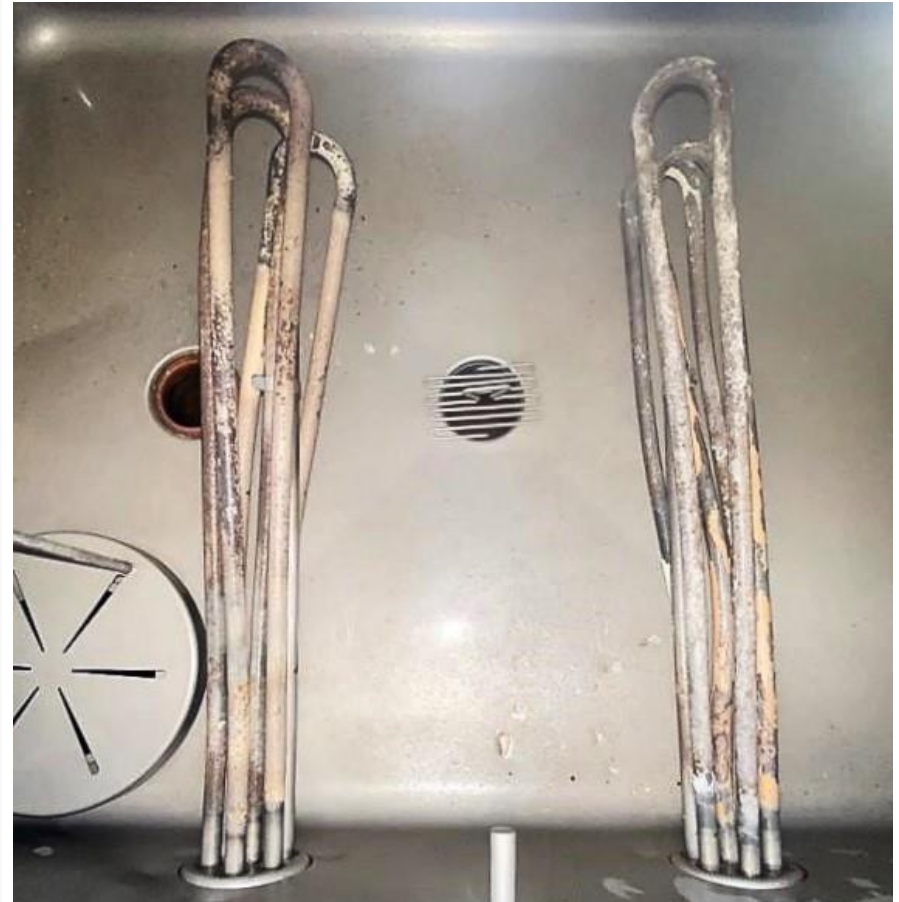
After treatment (4 months), the image clearly shows that the surface is losing scaling at most of spots and also the sink in background looks pretty clean

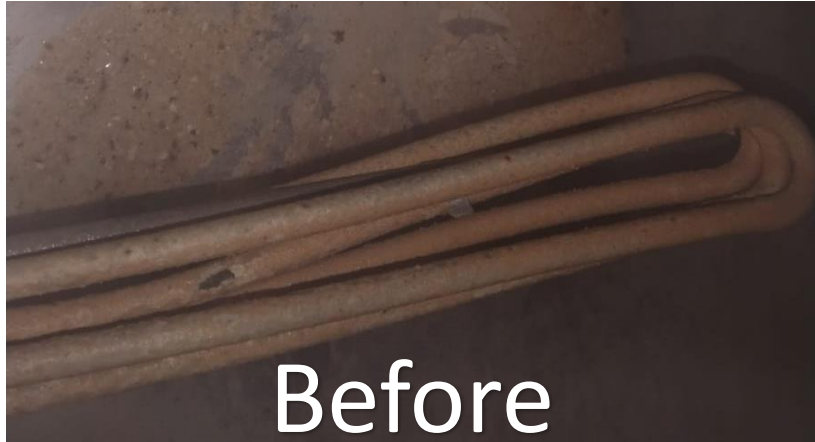
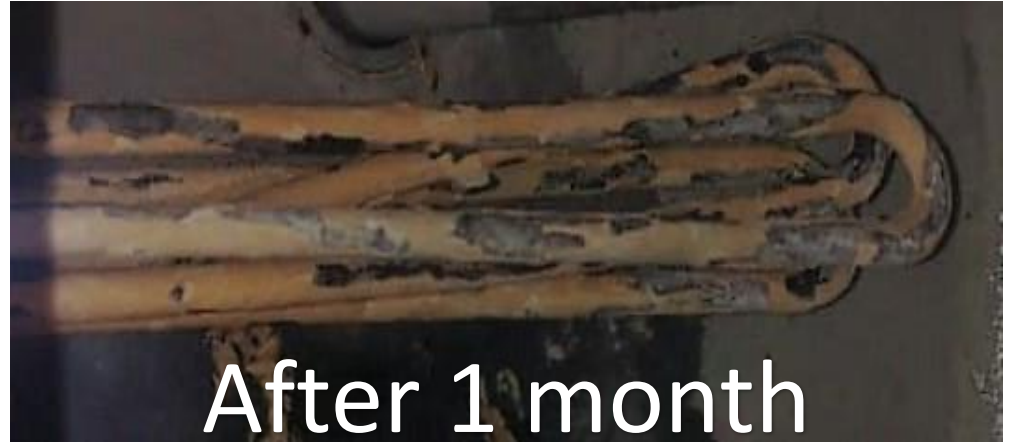
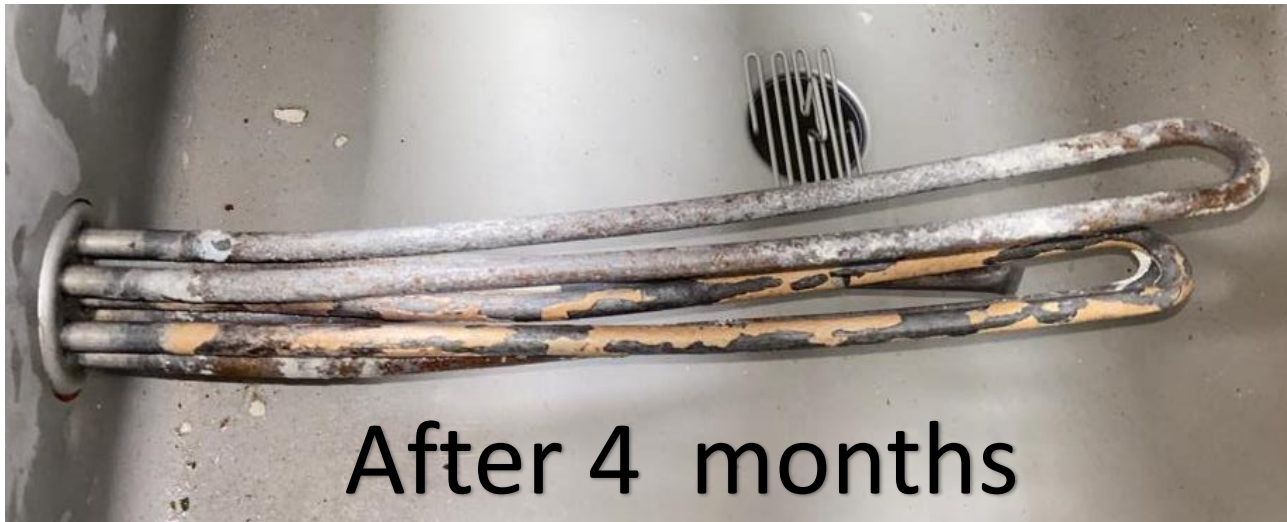
Close up of heating element and tank shown after 4 months of continuous Scalewatcher treatment.

SW treated the dishwasher as good as if it's a brand new one.
