Monitoring Report

Nass Corporation B.S.C.

ScaleWatcher Installation Report for RO System
and Truck Radiator Protection System

August 13, 2016

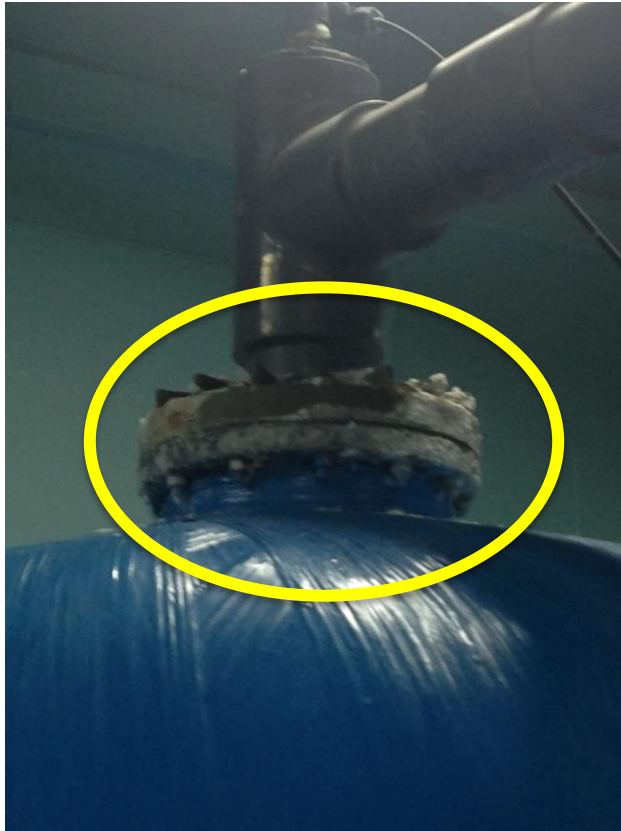
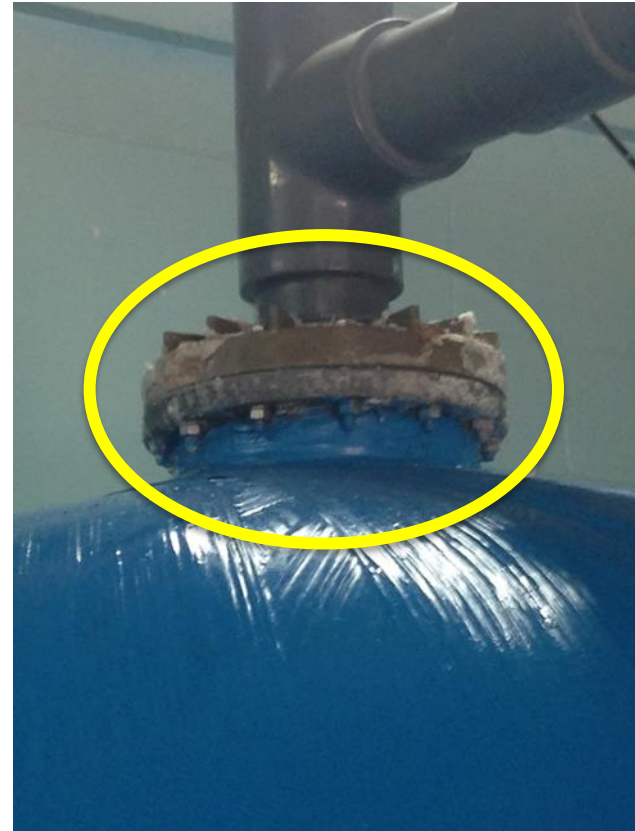
Side by Side Comparison

July 16, 2016- SW was fully installed

July 27, 2016- after SW was fully installed (11 days only)

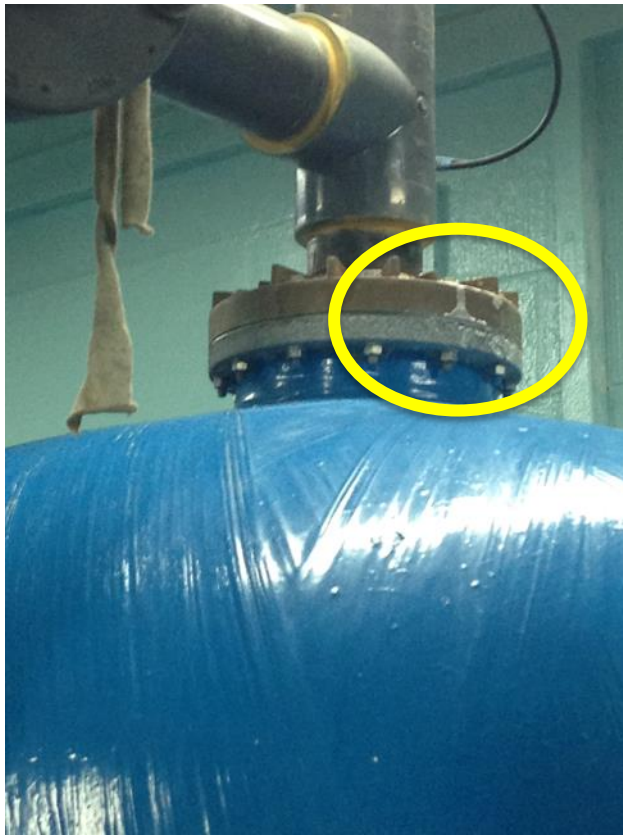
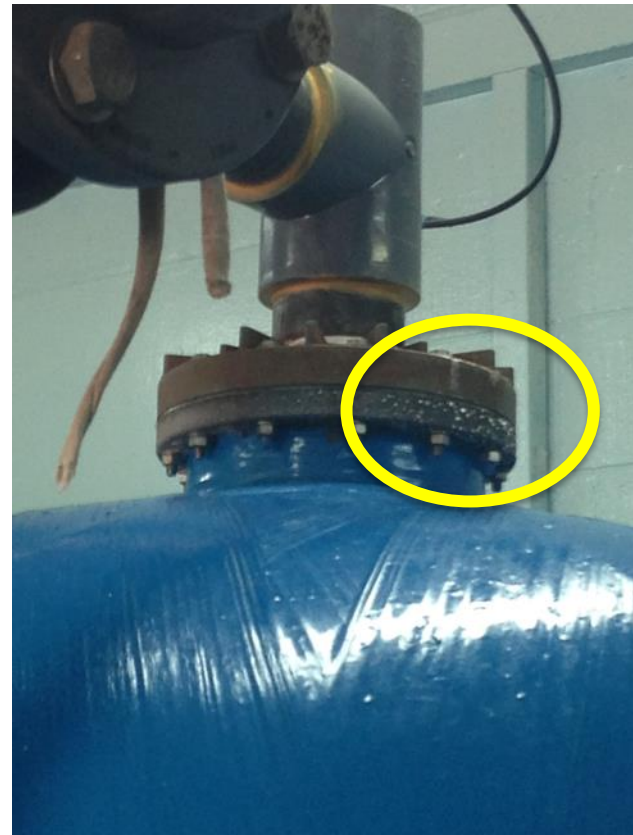
Side by Side Comparison

July 16, 2016- SW was fully installed

July 27, 2016- after SW was fully installed (11 days only)

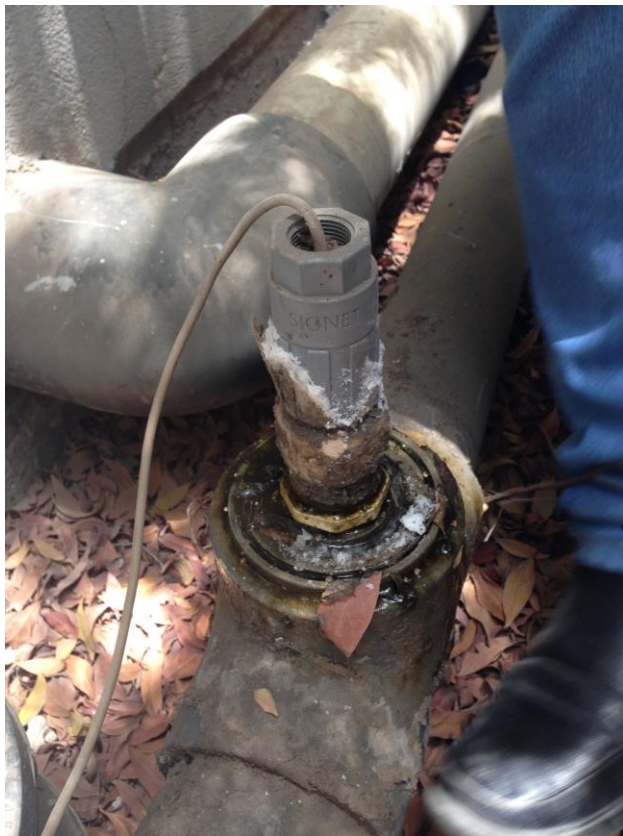
Hard external scaling started to soften

- Turn ON and implement a NON-STOP operation of the installed SW water treatment to fully realize its benefits.
- Implement the 30-50% reduction of chemical water treatment and conduct a weekly monitoring based on water parameters required by the Ministry.
- An internal QC team for the RO system is highly recommended to fully monitor the RO system performance and checking balance for the company's interest.

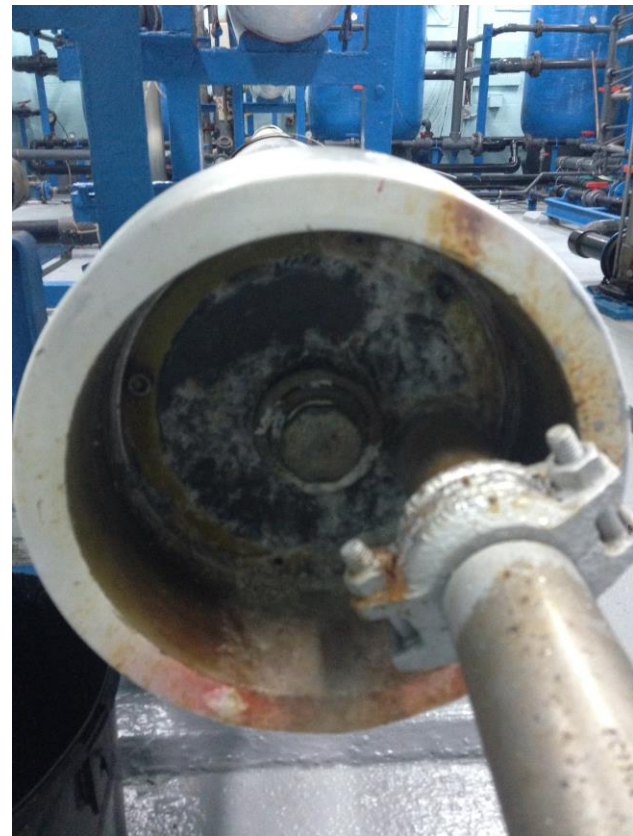
Scaling in the RO Membranes started to soften and water leaking has been minimized.

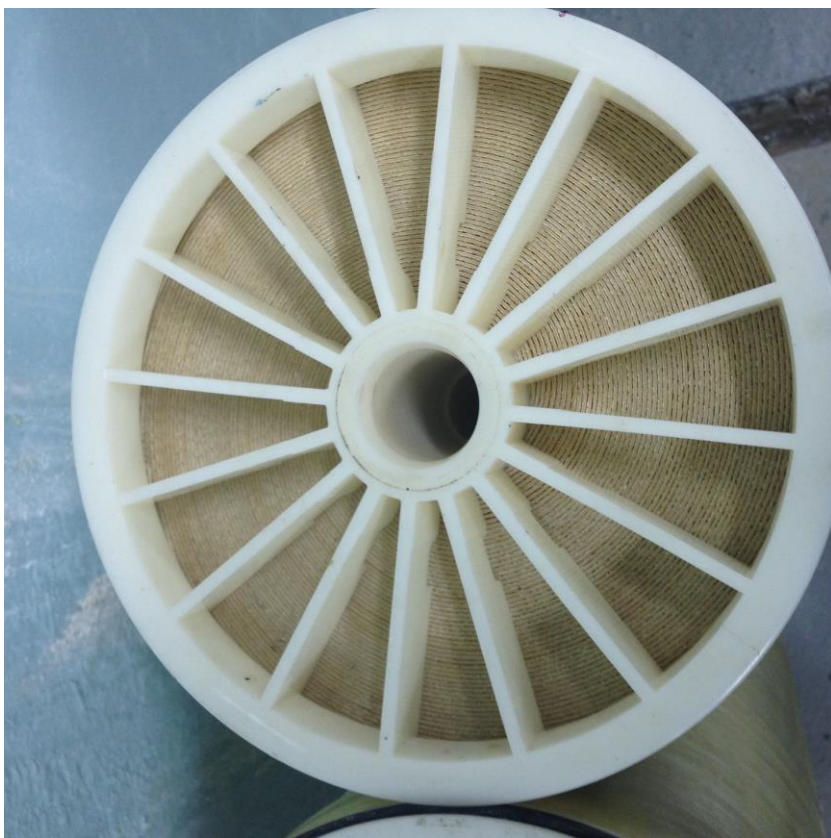
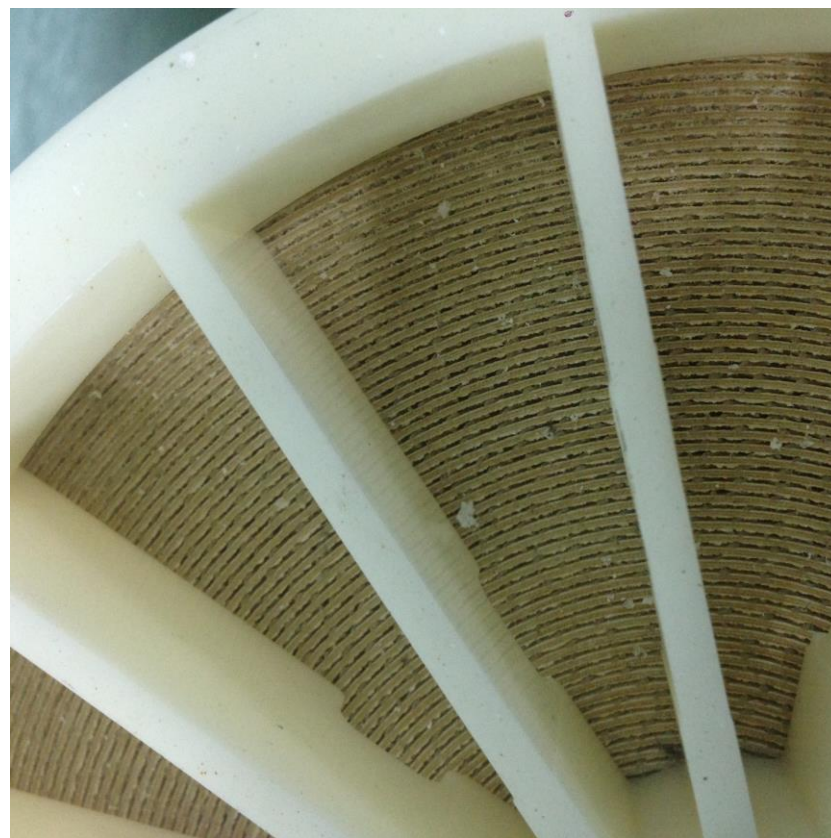
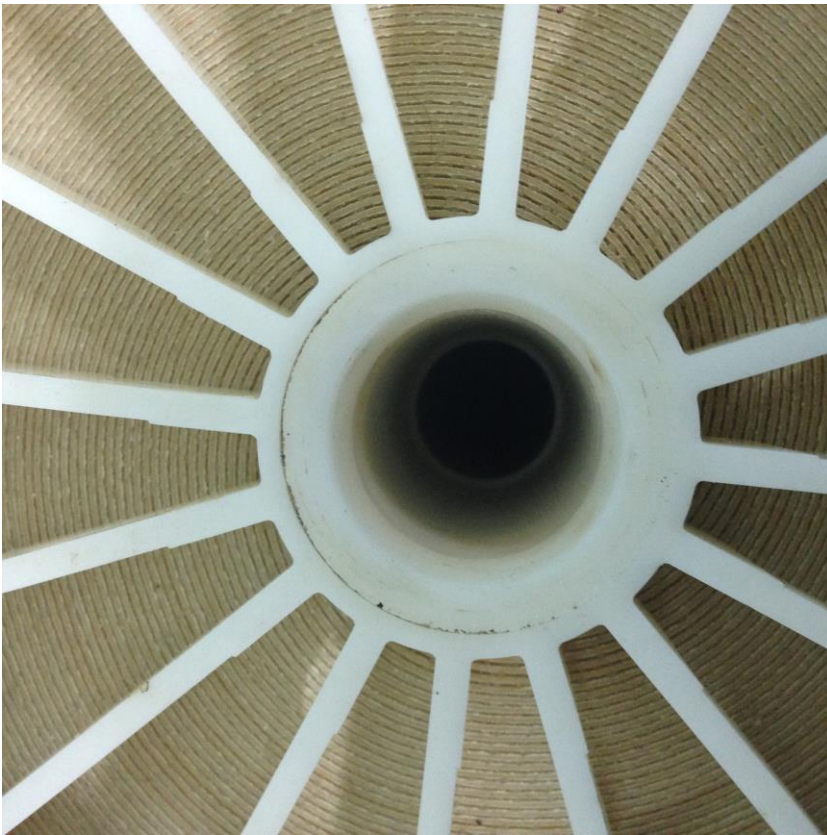
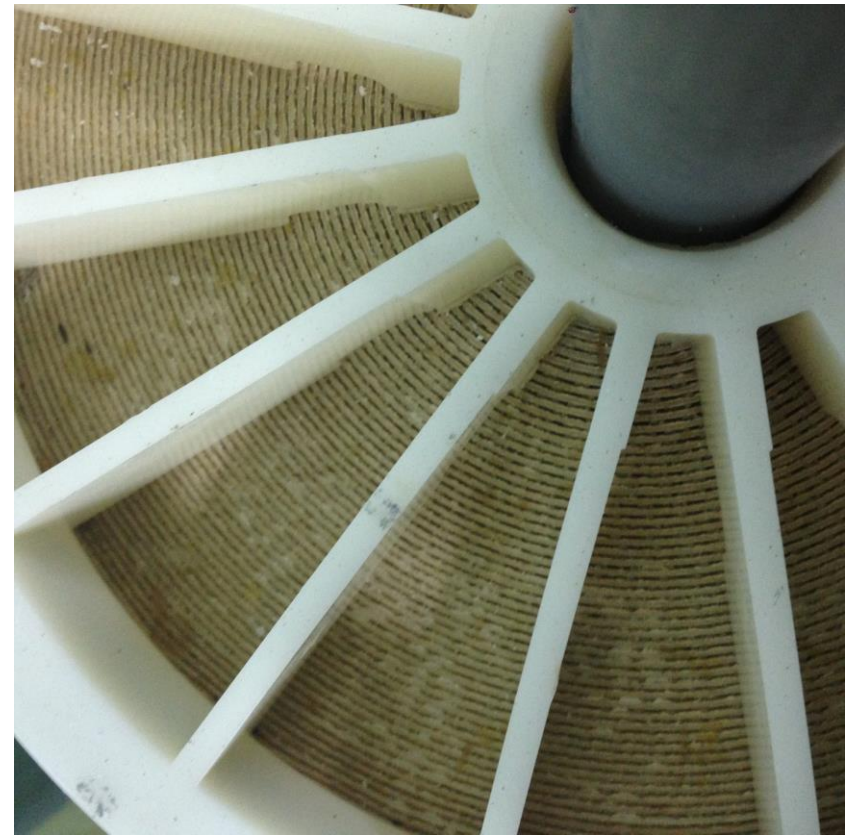
Nass Corp.- RO membranes which are prematurely replaced resulting to high maintenance expenses

- External hard scaling in the RO system, pipelines and fitting has started to soften in just 11 days after SW was fully installed.
- TDS did not change. This is possible due to high usage of chemical maintenance such as acids, Cl and descalers resulting to high operational expenses for the RO system; premature replacement of RO membranes.
- Water leaking in the pipeline and fitting has significantly improved.
- Maintenance program is ONLY being handled and performed by 3rd party maintenance team- Rain Drops. No internal QC team from Nass- for checking balance purposes.
- SW electronic water treatment was shutdown for 9 days (since Aug. 04, 2016) already as ordered by Mr. Roy Matthews of Rain Drops- a chemical water treatment supplier of Nass Corp.
- 1 vessel composed of 5 membranes was prematurely replaced as recommended by Mr. Roy Matthews.
